# Fundão Tailings Dam Review Panel

## Report on the Immediate Causes of the Failure of the Fundão Dam

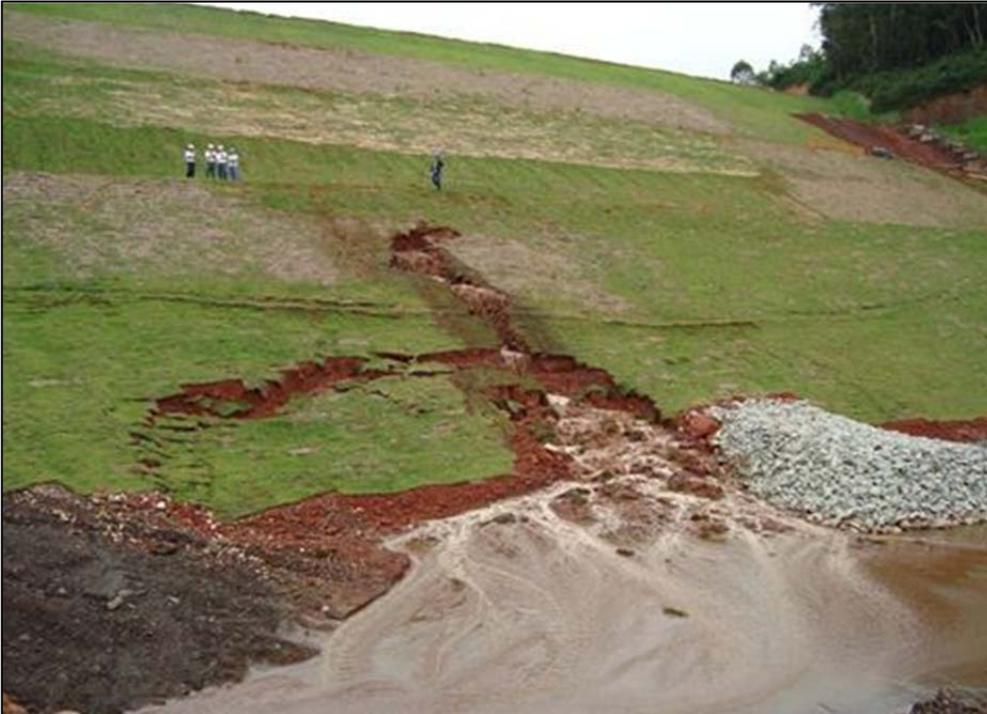
**Figure 2-6 Internal erosion effects on downstream slope of Dike 1**

Construction of the Dike 1 Starter Dam, with its requisite drains and galleries, was completed in October, 2008. Shortly after full-scale discharge of sand tailings began on April 13, 2009, large seepage flows carrying fines appeared on the downstream slope above the main underdrain as shown on Figure 2-6, conditions symptomatic of the process of *piping* or *internal erosion*.

An Emergency Action Plan in place for the dam at that time was immediately implemented. The reservoir was lowered, a berm was constructed over the affected portion of the dam slope, and provisions were made for holding the reservoir's remaining contents in the downstream Santarem Dam should failure occur. Engineering investigations later revealed serious construction flaws in the base drain and its filters, including a portion of the drain's outlet that had never been completed. This allowed water pressure within it to build until causing the slope to erode and slump.

As these investigations continued, the impending rainy season made it too late to fully restore the drainage features to their original condition, making it impossible to repair the damage. Instead, all of the drains were sealed. With this, the most important element of the original design concept became inoperative.

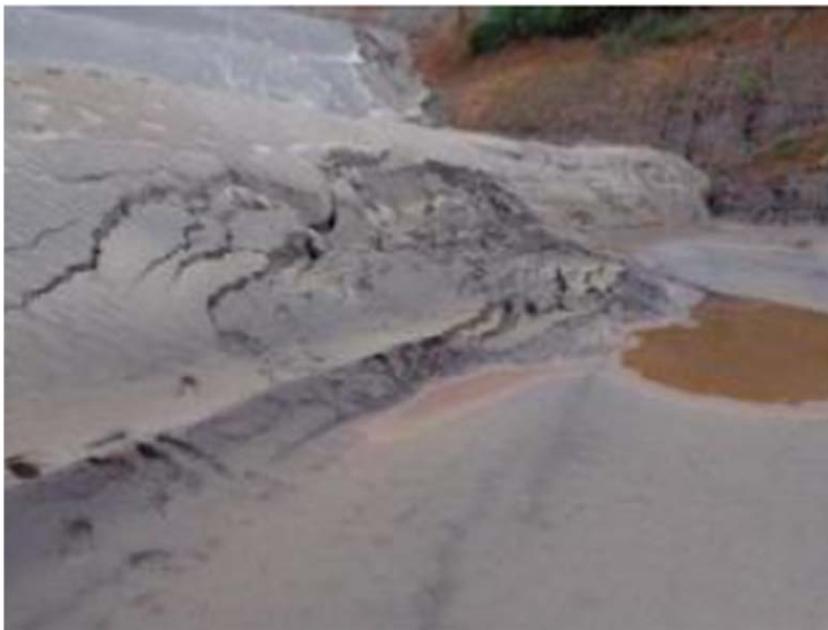
**Figure 2-11** November, 2013 seepage, cracking, and slumping at left abutment El. 860 m

Filling of the Secondary Gallery was completed on August 22, 2013. Meanwhile, dam raising had continued, with seeps that began to appear at the left abutment as early as June 26, 2012, at El. 845 m. In February, 2013, three-dimensional seepage modeling of the 920 raise showed that additional drains would be needed at the abutments if seepage breakout were to be prevented. This analysis was borne out when seepage, saturation, and cracking began appearing at several locations at the left abutment during 2013. The first such incident occurred in March at El. 855 m, followed by another seep in June at El. 855 m. Both were treated by constructing a drain. A third seep on November 15 appeared at El. 860 m and was accompanied by slumping of the slope shown on Figure 2-11. Another drain was provided to address this condition. On December 26, seepage occurred at El. 860 m and there was cracking on the left abutment crest at El. 875 m.

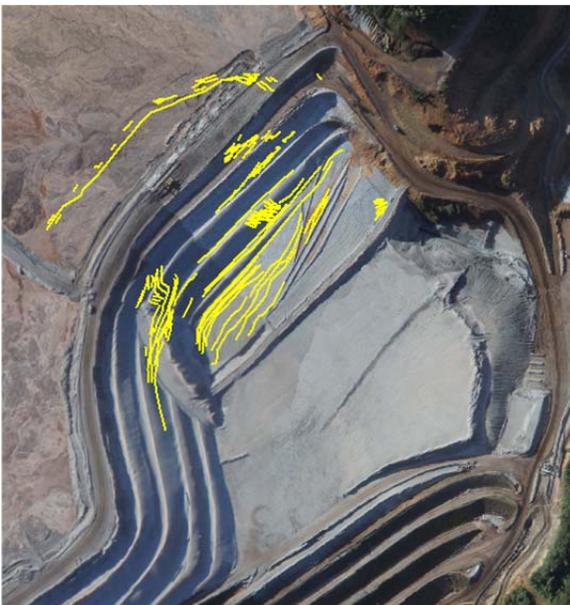
**Figure 2-14** August 27, 2014 cracking at left abutment setback

Just after sunrise on August 27, 2014 a series of cracks much more extensive than anything that had occurred the previous year were discovered that extended behind the dam crest, emerged at the toe, and encompassed most of the slope as shown on Figure 2-14. Accompanying the cracking was shallow saturation at the toe, as shown on Figure 2-15.

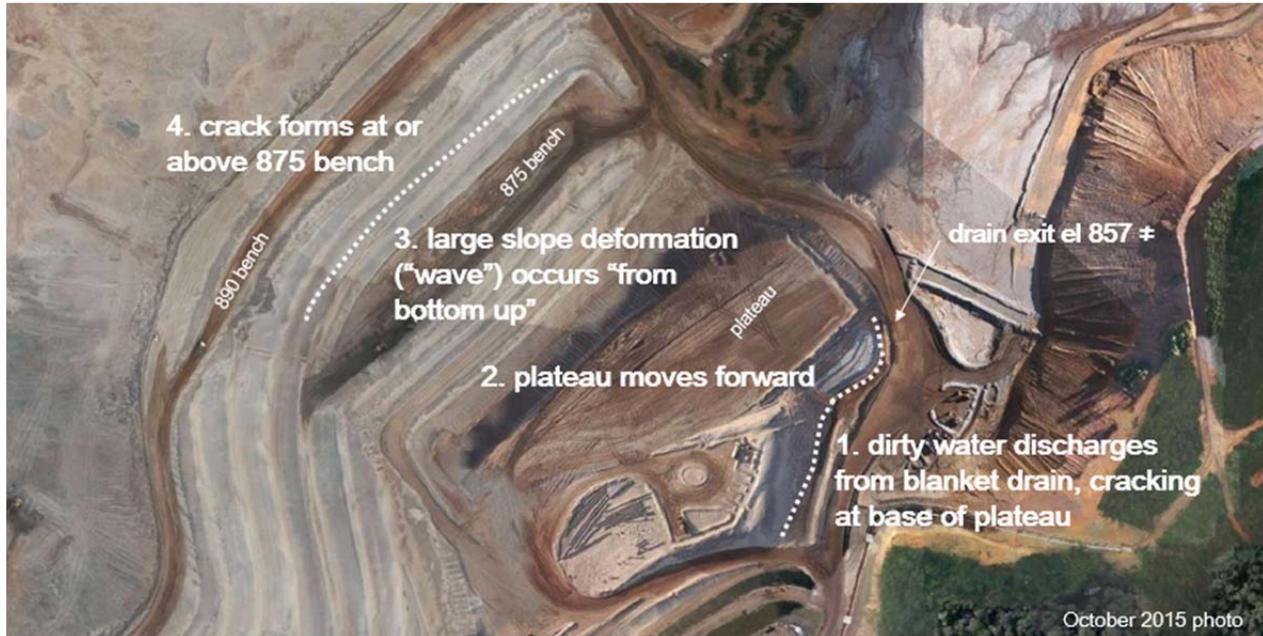
**Figure 2-18 Failure initiation sequence**

Taken together, these eyewitness observations can be synthesized into the sequence of events at failure initiation portrayed on Figure 2-18.

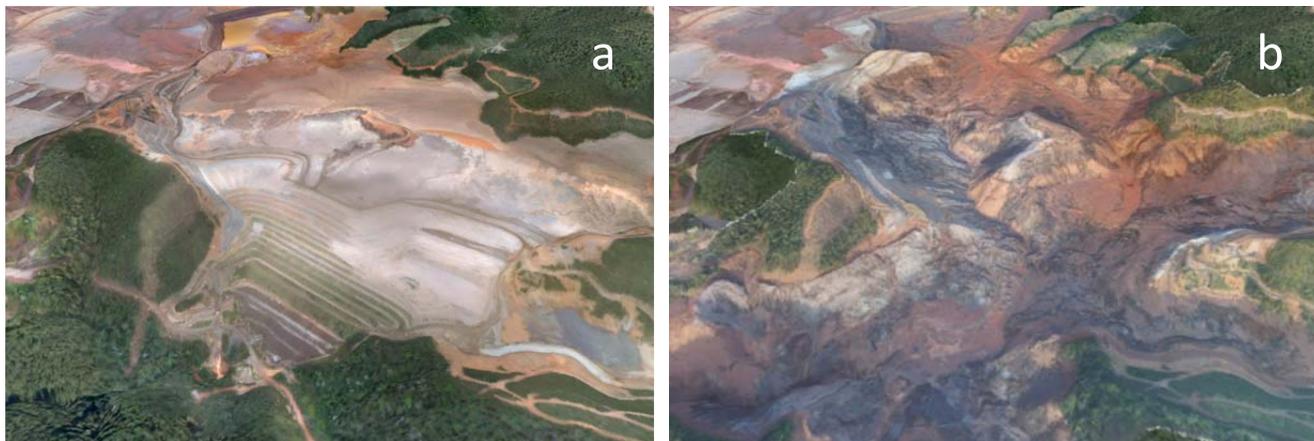
**Figure 2-19 Fundão damsite and reservoir (a) before, (b) after failure**

A conveyor crossing the Fundão stream channel about 1300 m downstream from the offset crest stopped functioning at 3:49PM, four minutes after failure is reported to have begun at 3:45PM. From this, it is ascertained that the flowslide was moving at about 11 m/s by the time it reached the conveyor. It is calculated that 32 million m<sup>3</sup> of tailings was lost, representing 61% of the impoundment contents—an unusually high proportion in relation to tailings dam failure statistics. In a matter of hours, the Fundão Dam was gone, and what once had been Figure 2-19(a) became Figure 2-19(b).

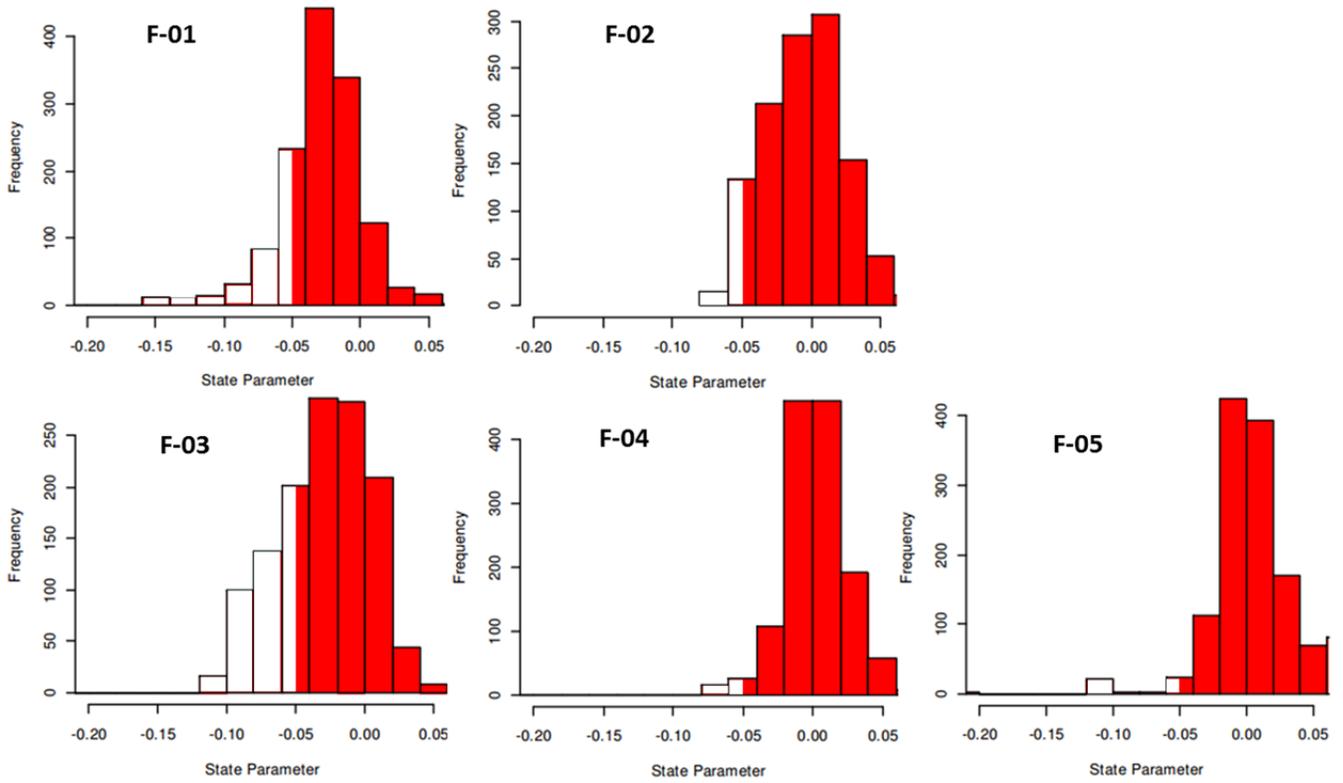
**Figure 4-4** Histograms of state parameter for Fundão sand tailings

On this basis, approximately 70% to 80% of the sand tailings within 75 m of the dam crest are indicated to have been contractive, and 95% or more at greater distance up to 180 m. This demonstrates that the majority of hydraulically-discharged Fundão sand tailings satisfied the contractiveness requirement for liquefaction flowsliding. This is confirmed by CPT-based liquefaction criteria developed by Robertson (2010) on Figure 4-5 that supplements state parameter with liquefaction field case histories. These include flow liquefaction of the Nerlerk offshore berm for the encircled point labeled 19, 20, and 21, a case that figures prominently in the Fundão assessment as subsequently explained in Section 6.

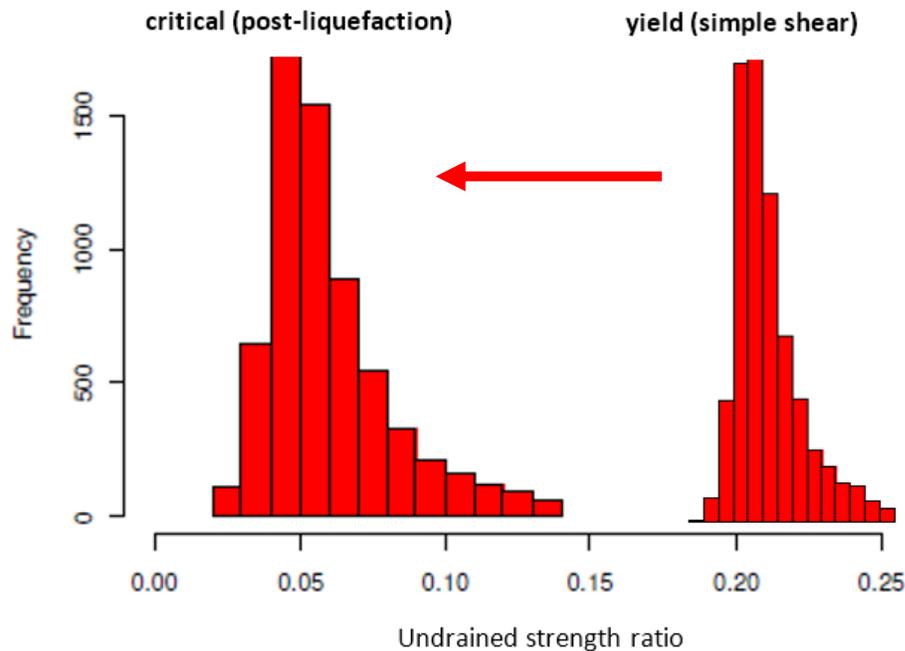
**Figure 4-6 Yield (pre-flowslide) and critical (post-flowslide) undrained strengths for aggregated 2015 Fundão CPT data**

Figure 4-6 shows that mean undrained strength ratio dropped from 0.21 before the flowslide to 0.07 during it, demonstrating that the Fundão sand tailings were susceptible to significant loss of strength.

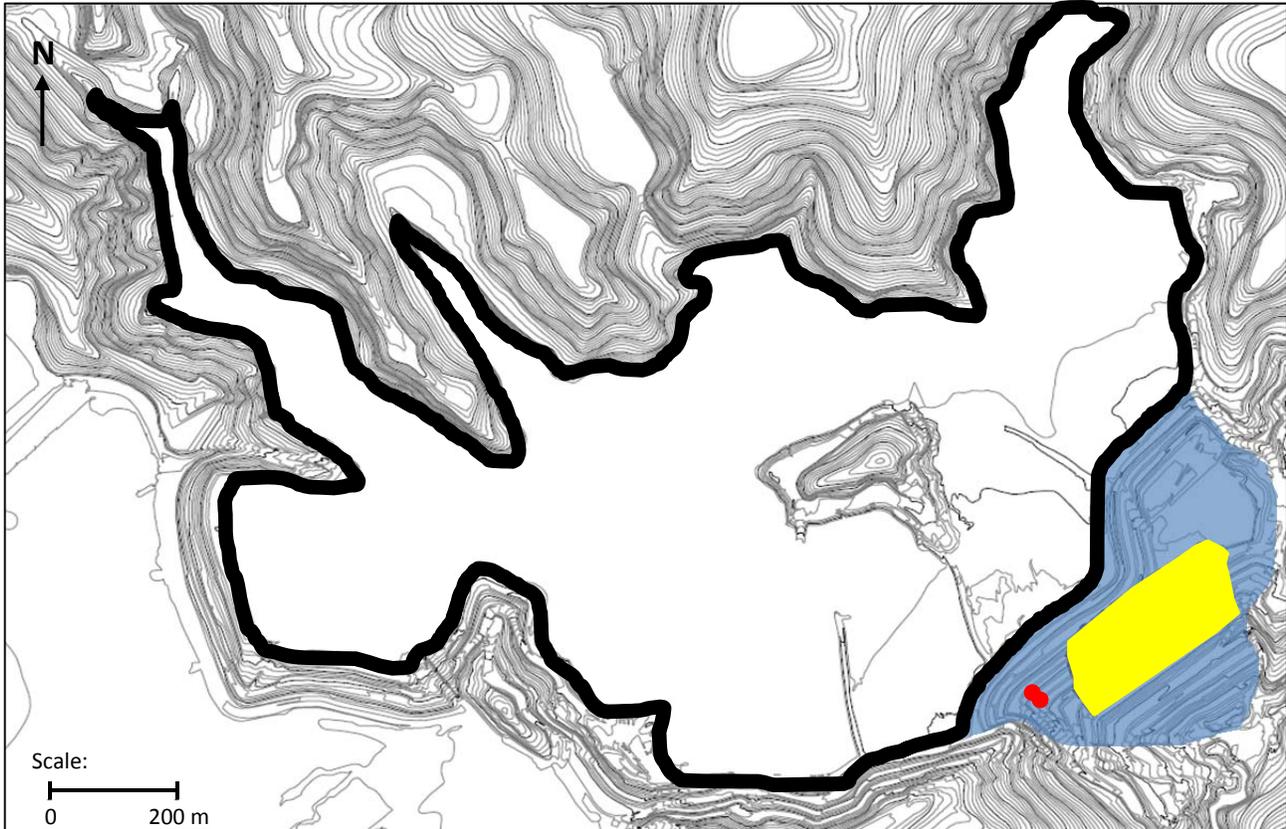
**Figure 4-9 August, 2014 configuration showing El. 826 m blanket drain, raised dam, impoundment outline, and right abutment seeps (red dots)**

Figure 4-9 shows that by August, 2014 the impoundment had nearly doubled in size, principally on the right side. With this enlargement came a seep on the right abutment at El. 855 m in July, followed by another in January the next year. As upstream raising continued, the impoundment became even further removed from the drain, expanding the volume of saturated tailings behind it still further.

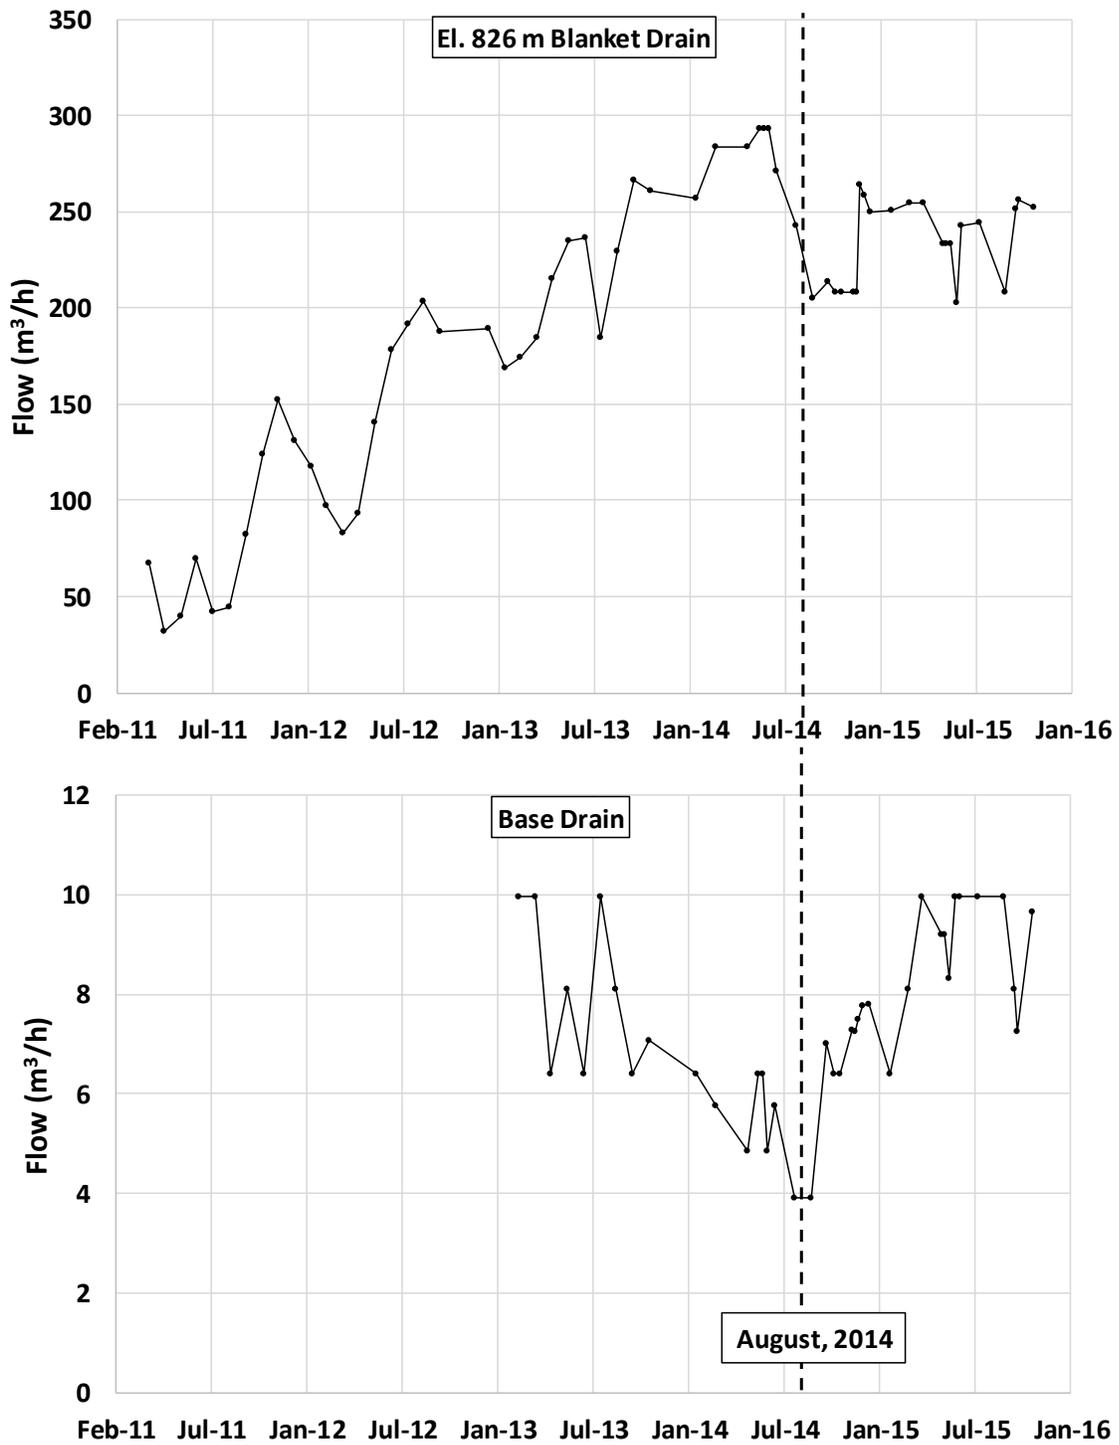
Figure 4-10 Measured flows from El. 826 m blanket drain and Starter Dam base drain

An explanation consistent with these events is that the El. 826 m blanket drain with its Kananet® outlet pipes reached its maximum capacity. With the drain unable to divert additional seepage, saturation on the right abutment increased, breaking out in July at El. 855 m. At the same time, the diminished effectiveness of the blanket drain caused base drain flow to reverse its previous trend and begin increasing, while related increase in flow into the foundation caused artesian conditions to appear at the Starter Dam toe. And, as discussed subsequently in detail, all of these things were accompanied by the shallow saturation and unprecedented cracking of the left abutment that also occurred in August, 2014.

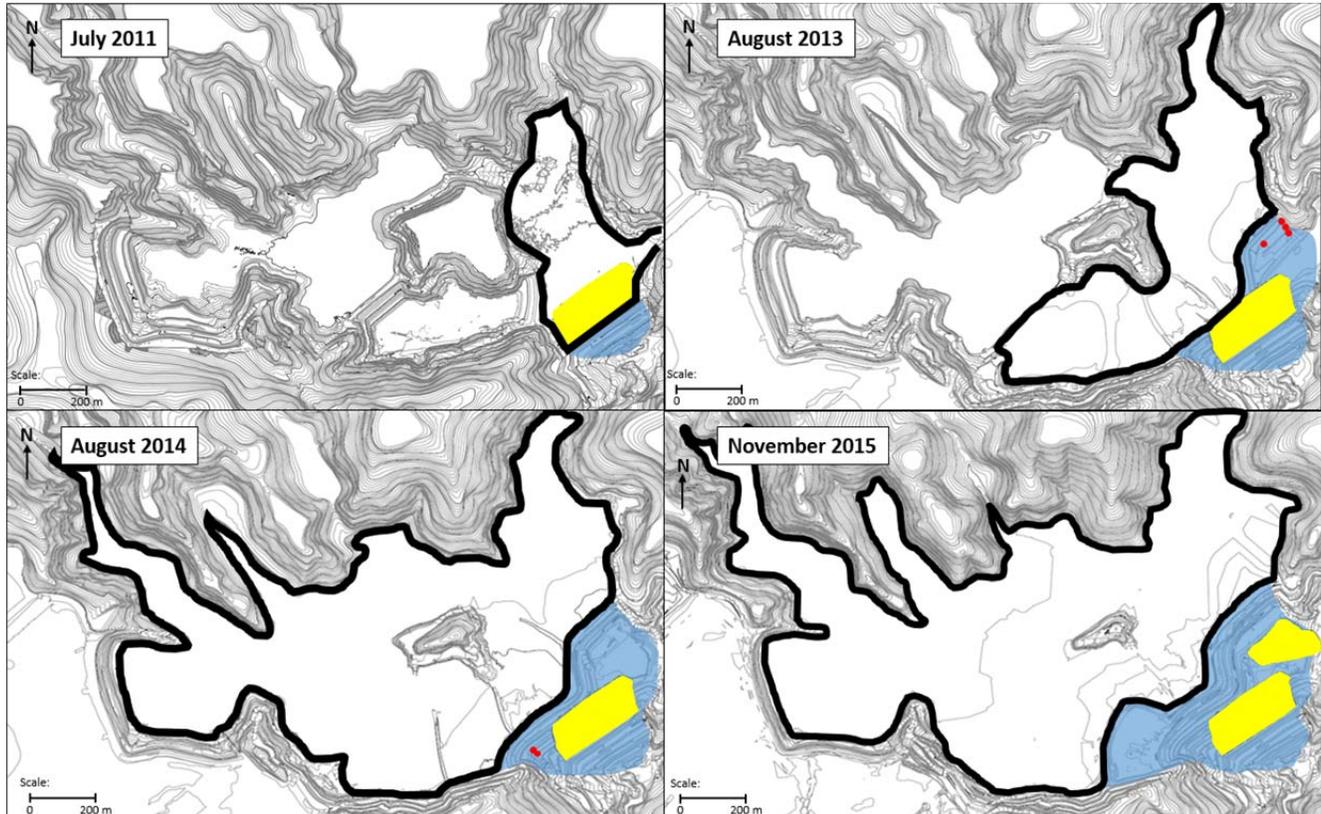
**Figure 4-12 Progression of impoundment and drainage provisions with time**

Figure 4-12 summarizes the time-sequence of these impoundment drainage provisions. As upstream raising continued and the impoundment expanded, the El. 826 m blanket drain became increasingly more distant from the tailings it was intended to drain and eventually could no longer keep pace with rising saturation levels. With this, the saturated conditions necessary for liquefaction flowsliding were satisfied.
