# Fundão Tailings Dam Review Panel

## Report on the Immediate Causes of the Failure of the Fundão Dam

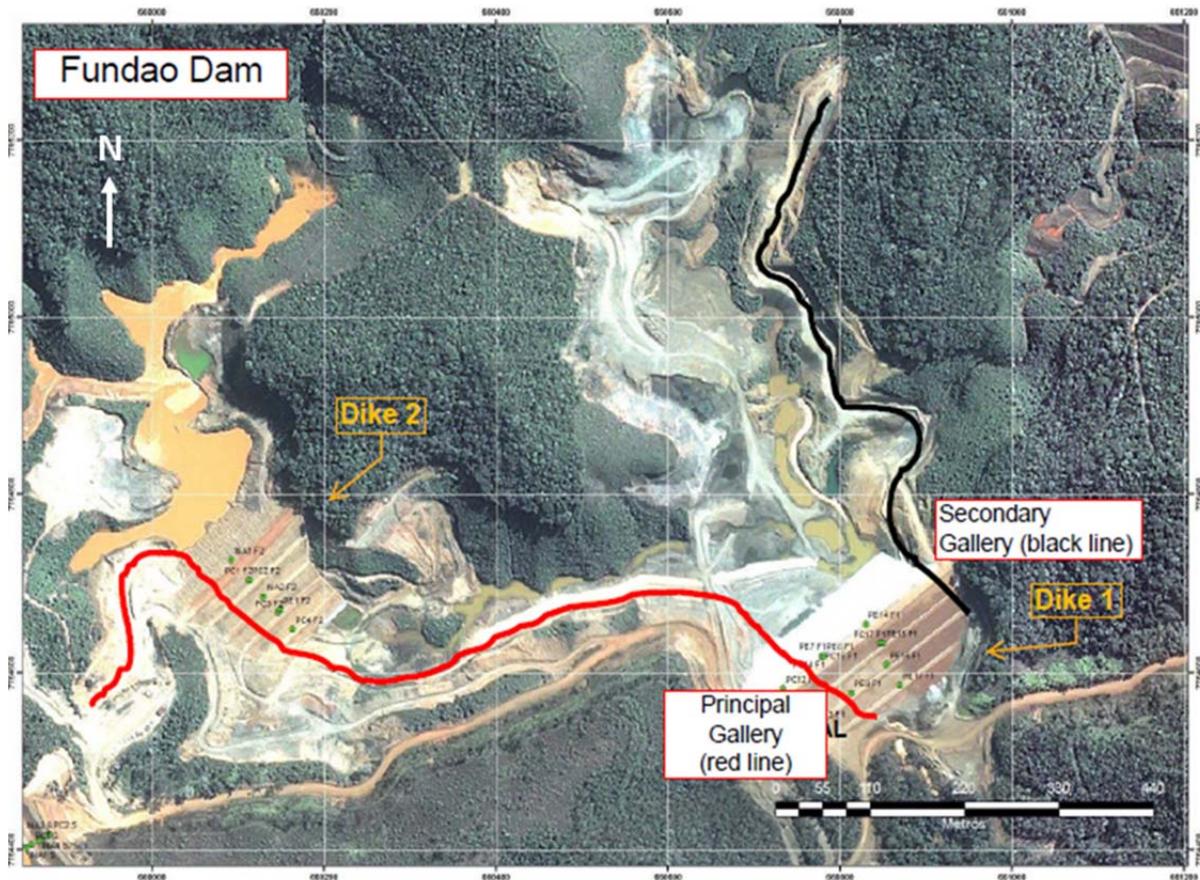
**Figure 2-5 Main (Principal) and Secondary Galleries**

Even as recovery from the 2009 Starter Dam piping incident remained underway, new conditions were developing that would directly affect the left abutment. The galleries shown on Figure 2-5 that evacuated water from the Fundão impoundment were found to be structurally deficient. This first

Because the height of tailings at the left abutment already exceeded the load capacity of the Secondary Gallery, the dam could not be raised any further over this area until the plugging operation was completed. As a temporary solution, it was decided to realign the dam at the left abutment by moving it back behind the portion of the gallery to be filled with concrete so that embankment raising could continue. This realignment shown on Figure 2-10 became the “setback”.

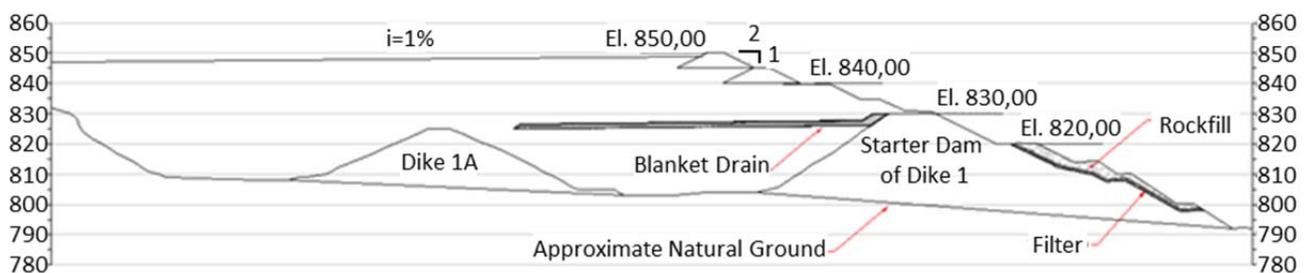
Figure 2-8 El. 826 m blanket drain (section) showing extent behind Dike 1

Comparing Figure 2-8 to Figure 2-1, it can be seen that the new blanket drain represented an attempt to replicate the drained-stack concept by providing drainage for the overlying tailings. But the sands below this drain would remain saturated, as would much of the tailings behind it. Once the base drain became inoperative, the control of saturation embodied in the original design concept could not be restored.

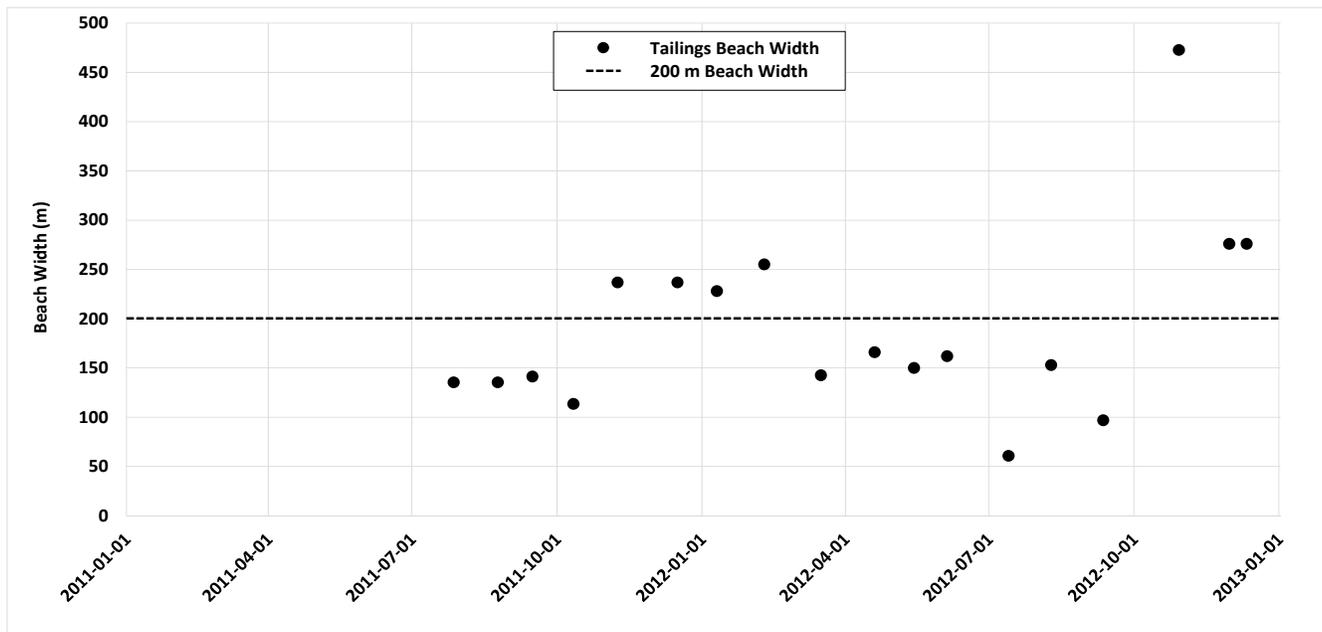
**Figure 2-9 Monthly beach width measurements by Samarco, 2011-2012**

But as operation proceeded, this beach-width criterion was not consistently achieved. As explained in greater detail in Section 5.1.3, a new Overflow Channel was conveying water and slimes from Dike 2 to the rear of the Dike 1 reservoir, making beach management more difficult. No longer were the sands and slimes physically separated; the interface between them could only be controlled by adjusting the amount of sand spigotted from the dam crest in relation to the amount of slimes-laden water being introduced. As plotted on Figure 2-9 and documented in Appendix B, during much of 2011 and 2012, beach widths violated the 200 m minimum more often than not, at times encroaching to as little as 60 m from the crest.

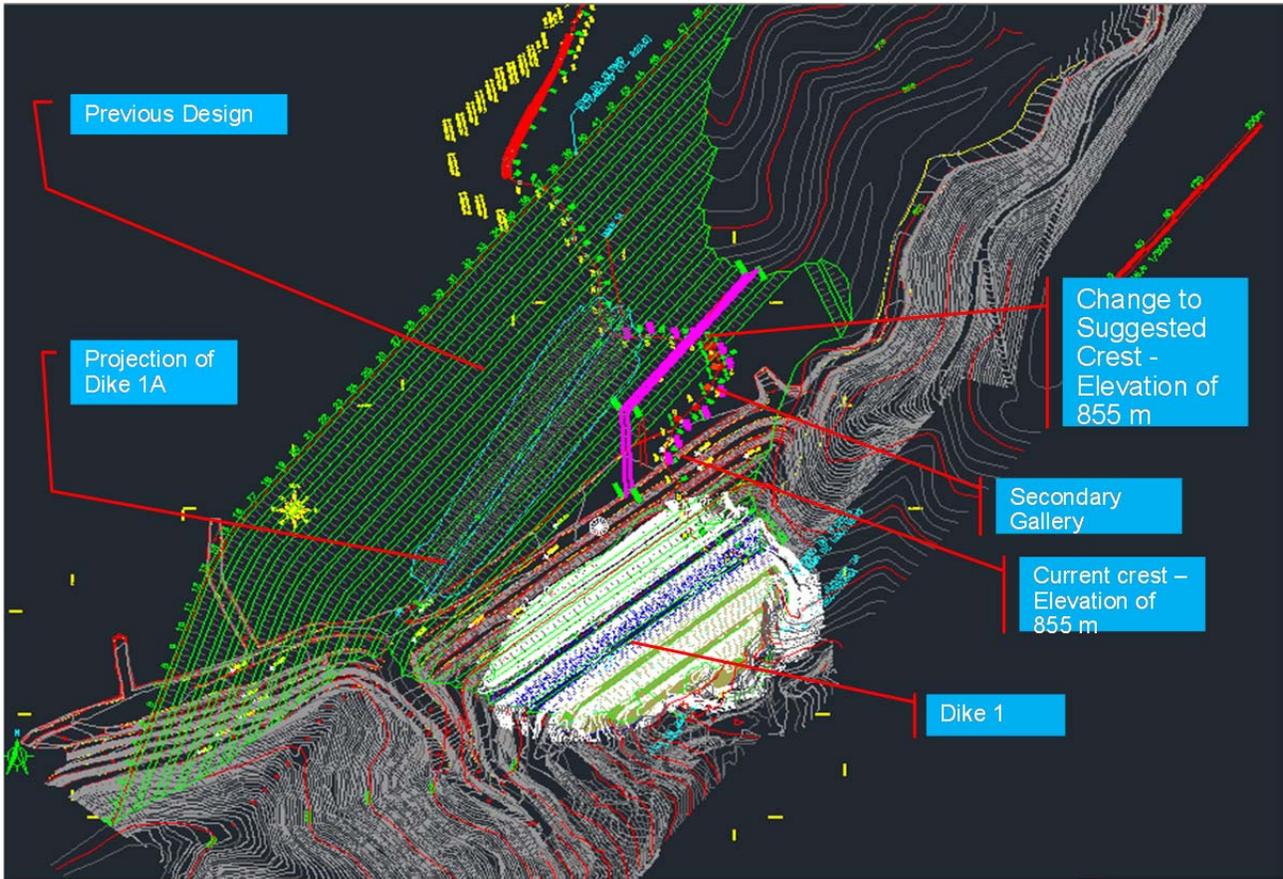
**Figure 2-10** Left abutment setback proposed in June, 2012

The setback would move the crest closer to the reservoir water and the slimes it contained, but it was anticipated that the dam would be quickly returned to its original alignment as soon as the plugging operations were done. At the same time, as will be explained more fully in Section 5, moving the crest back from its original alignment would also place it closer to, if not over, areas where beach encroachment and slimes deposition had already occurred.

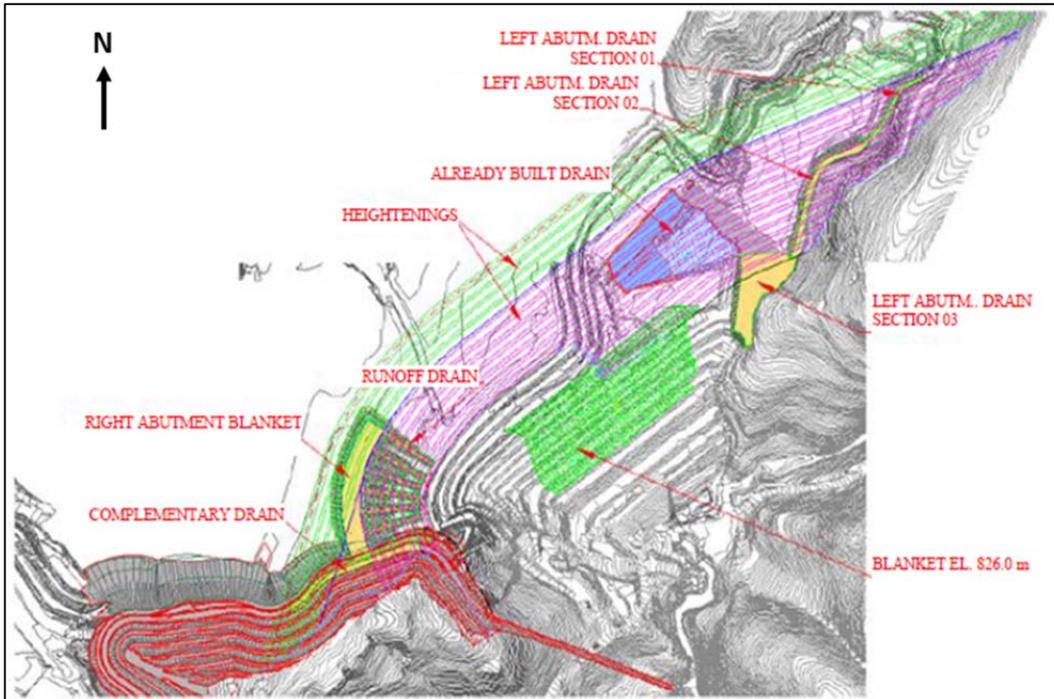
**Figure 2-12 Proposed drainage scheme for 940 raise**

Following these 2013 episodes of seepage and cracking, it had become apparent by January, 2014 that the El. 826 m blanket drain was no longer sufficient and that additional drains would be needed at the left abutment. This coincided with plans for an entirely new project for future raising of the dam by an additional 20 m from its then-planned maximum elevation of 920 m. Not only would this new El. 940 m raise add needed drainage features to the left abutment; it would eventually integrate them with an independent drainage system entering from the adjacent Grota da Vale and Fabrica Nova waste pile. As shown on Figure 2-12, the result would be what the Panel considers to be a complex and elaborate drainage system.

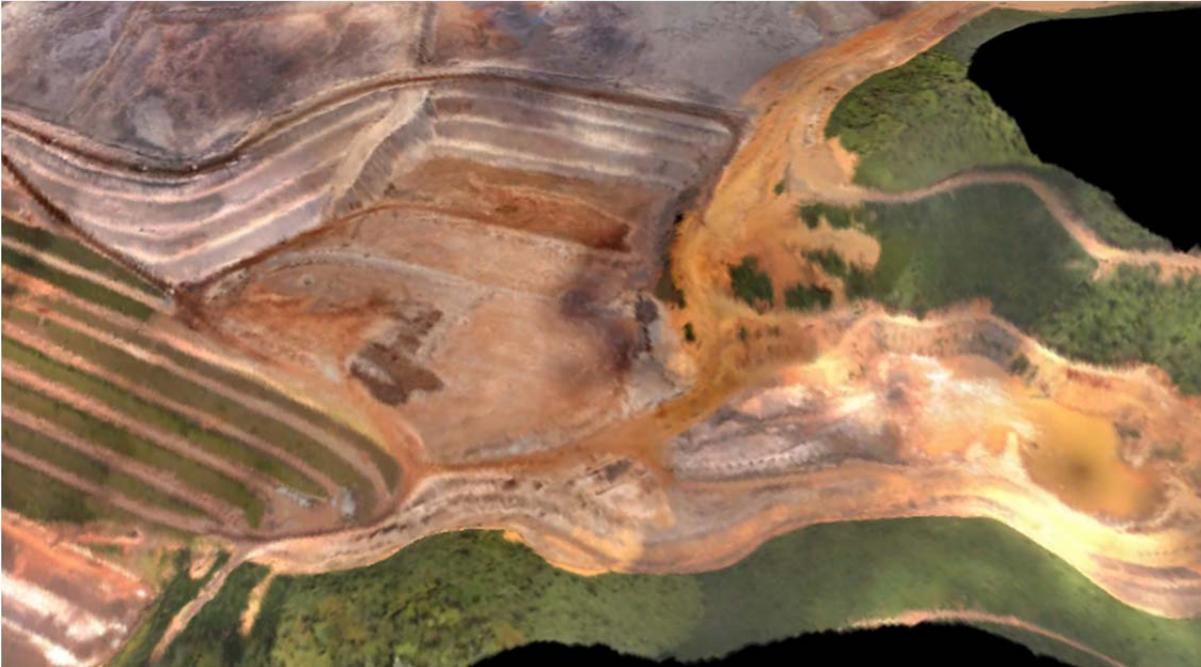
**Figure 2-13** Fundão Dam in January, 2014 showing left abutment setback and adjacent Grotta da Vale

The more immediate effect was that construction of additional drains in the left abutment area would require the setback to be maintained until they were completed. This entailed further delay in restoring the original alignment. As a result, the setback had risen at an average rate of 18 m/yr during 2013 and 3.0 m in September, a monthly record. In the 18 months since the setback decision had been made, the dam had grown by more than 20 m, and by January 2014 the Fundão Dam looked like Figure 2-13.

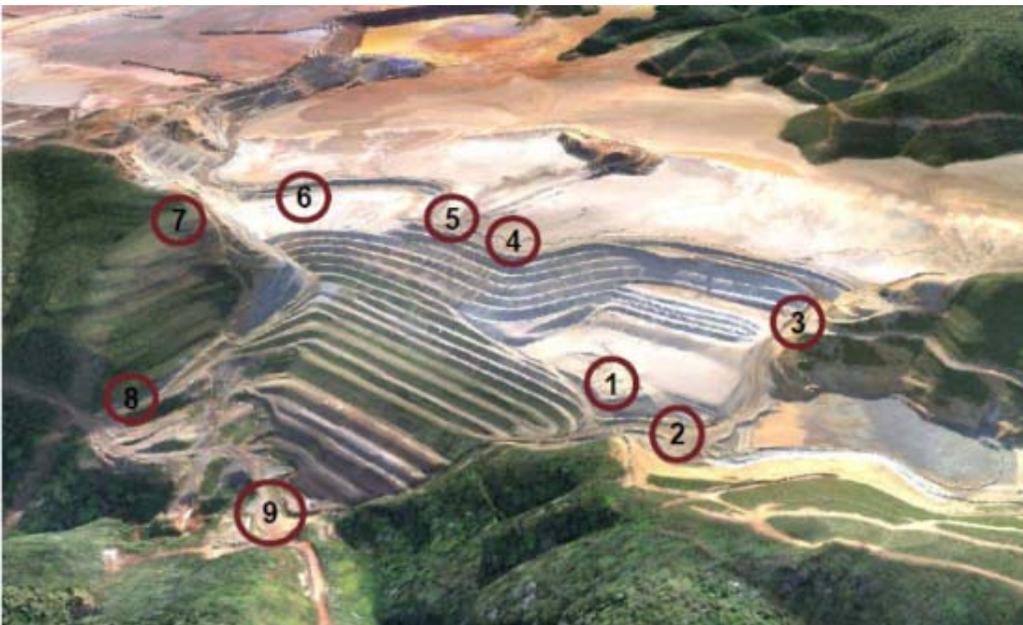
**Figure 2-17 Eyewitness locations on the afternoon of November 5, 2015**

On the afternoon of November 5, 2015, most activity was on or near the right abutment where drains were being constructed, placing several workers in a position to see along the length of the dam crest. On the left abutment, fill was being placed on the El. 875 m bench of the setback in preparation for start-up of cyclone sand placement. Figure 2-17 shows the locations of eyewitnesses engaged in these and other activities at the time of failure.

The first thing noticed by many workers on the dam, including those at locations 4 and 6, was a cloud of dust drifting up from the left side heralding the failure. A worker at 4 watched as waves developed in the central portion of the reservoir, accompanied by cracks forming on the left side and blocks of sand moving up and down on the left abutment setback. Another worker at 5 saw a crack open up along the crest of the left abutment setback then propagate in both directions, beginning closer to the left abutment, reaching it, then progressing to the right. And at location 9 at the toe of the dam, witnesses experienced an avalanche of mud-like tailings cascading down from the left abutment, but no movement of the starter dike itself.

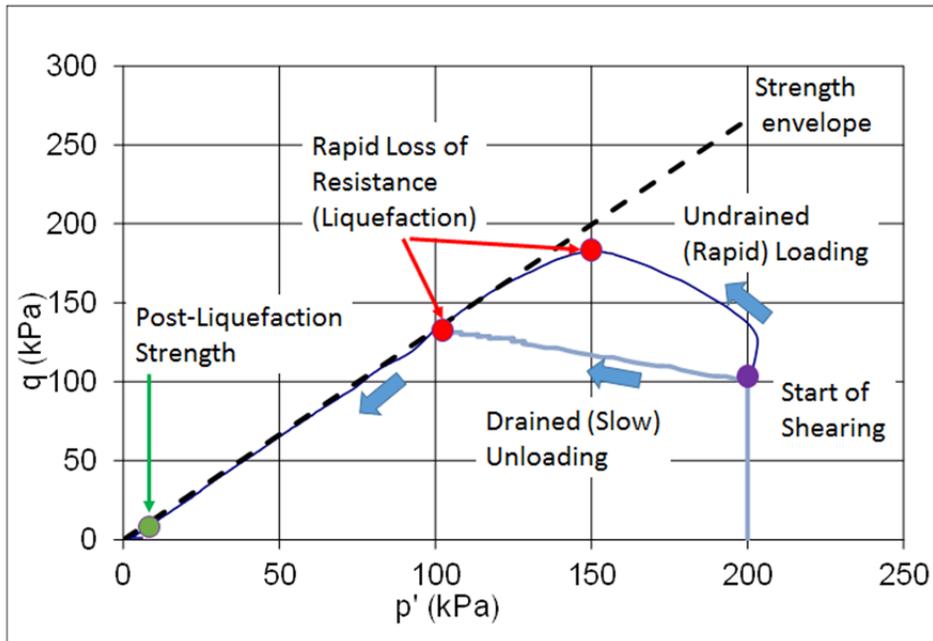
**Figure 4-1** Stress paths for undrained loading and drained unloading of sand, Fundão test data

In the first test, conventional undrained loading is applied to simulate rapid shearing. When the stress path reaches the strength envelope it reaches a condition of liquefaction. As shearing resistance reduces due to changes in pore pressure, it progresses downward along the envelope and strength rapidly diminishes until arriving at a very low *post-liquefaction* strength.

The second test represents a different stress path central to understanding the Fundão failure. Instead of being loaded, the sample is laterally unloaded to simulate horizontal spreading. In addition, the unloading process is conducted slowly under drained conditions. As seen on Figure 4-1, the behavior on reaching the strength envelope is the same as before: liquefaction occurs, strength rapidly decreases, and the same post-liquefaction value results. In both tests, the loss of strength accompanying liquefaction is dramatic and nearly instantaneous, so much so that this behavior is sometimes referred to as *collapse*. The parallels between this kind of behavior in the laboratory and that which occurred during the Fundão failure are evident.

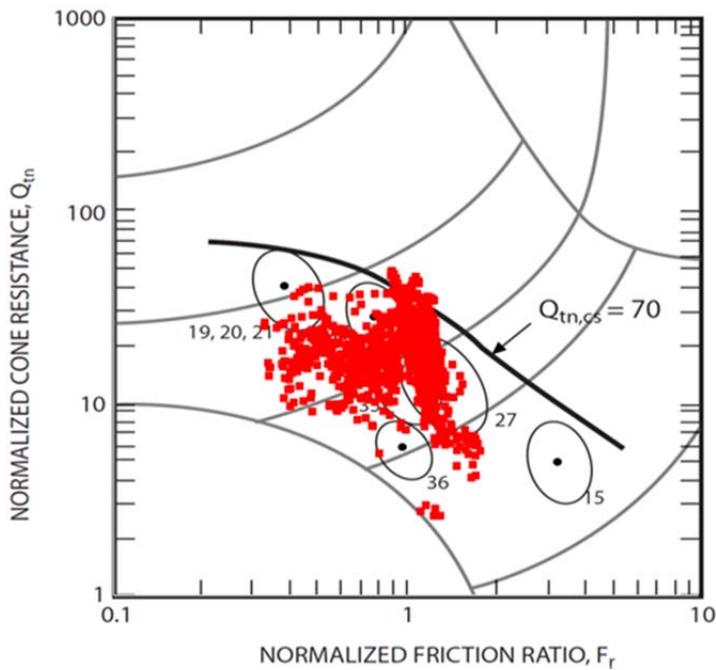
**Figure 4-5** Robertson (2010) liquefaction criterion for Fundão CPT F-02 data

With respect to the CPT profiles, the Panel has utilized the Robertson (2010) procedure previously shown on Figure 4-5 for evaluating the contractant/dilatant behavior of the deposits, primarily because it incorporates liquefaction failures of tailings dams and other deposits for immediate comparison. All CPT interpretations are available in Appendix C.

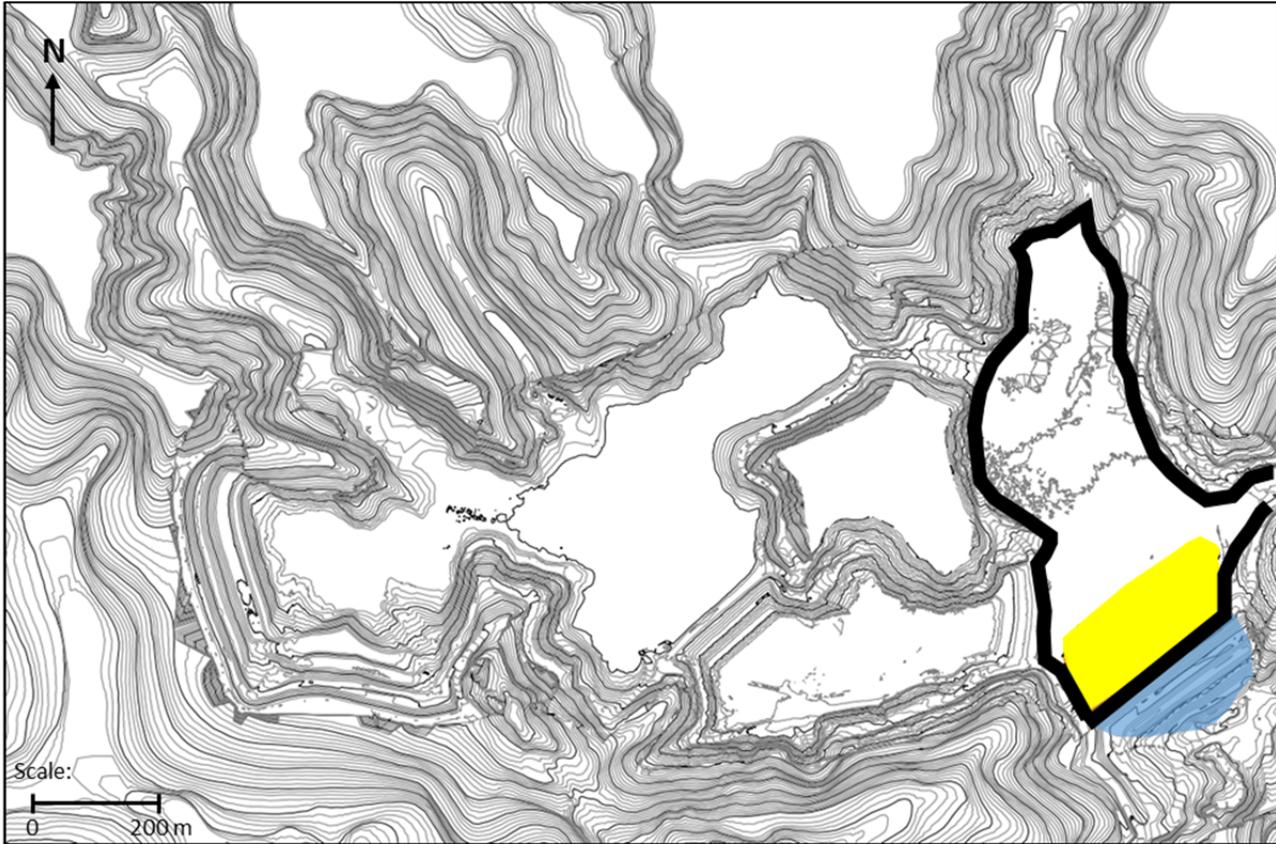
**Figure 4-7** July, 2011 configuration showing El. 826 m blanket drain (yellow), Starter Dam embankment (blue) and impoundment outline

The original concept became inoperative after the damage sustained to the Starter Dam in the 2009 piping incident. The revised design that emerged relied instead on a blanket drain at El. 826 m near the top of the sand that had nearly filled the Starter Dam by that time. The El. 826 m blanket drain, which included the Kananet® pipes, was called upon to carry nearly all of the seepage as the dam grew higher and the impoundment larger with time. It became increasingly unable to do so, resulting in expanding volumes of saturated tailings.

The progression of conditions that promoted saturation is best illustrated by the following series of figures that integrates this information. Figure 4-7 shows the blanket drain in July, 2011, shortly after its completion the previous November. At that time the drain spanned the entire width of the Starter Dam. In this early configuration—which most closely resembled the original drained-stack concept—the impoundment size was limited and the drain was beneath the discharged tailings where it could intercept downward drainage to maximum effect.

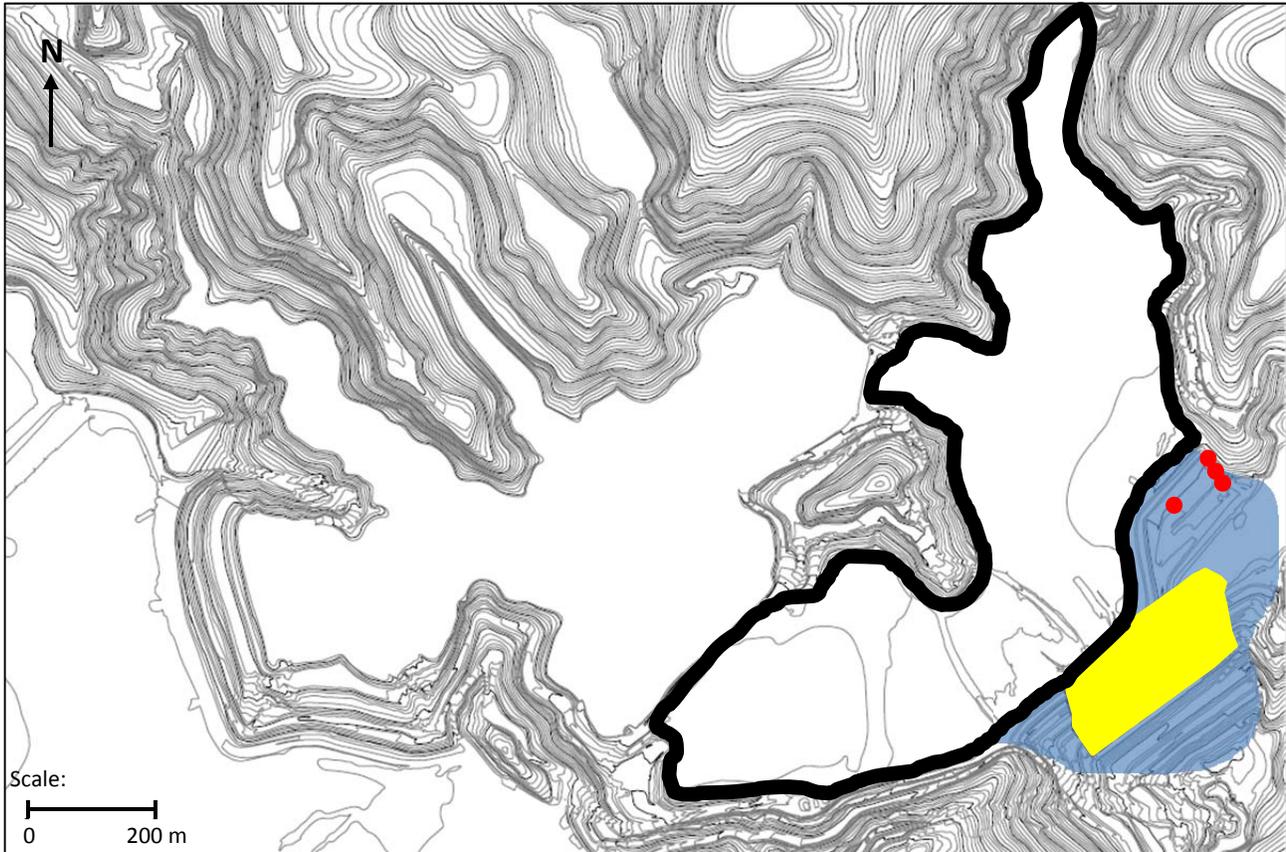
**Figure 4-8 August, 2013 configuration showing El. 826 m blanket drain, raised dam, impoundment outline, and left abutment seeps (red dots)**

Figure 4-8 shows that by August, 2013 both the embankment and impoundment had widened considerably as the dam grew higher, expanding beyond the limits of the drain on both sides. This had the effect of funneling seepage flow into the much narrower drain, and in the process raising the saturation level in the tailings. At the same time, the impoundment was moving upstream and becoming more distant from the drain as upstream dam raising progressed, also increasing the volume of saturated tailings.

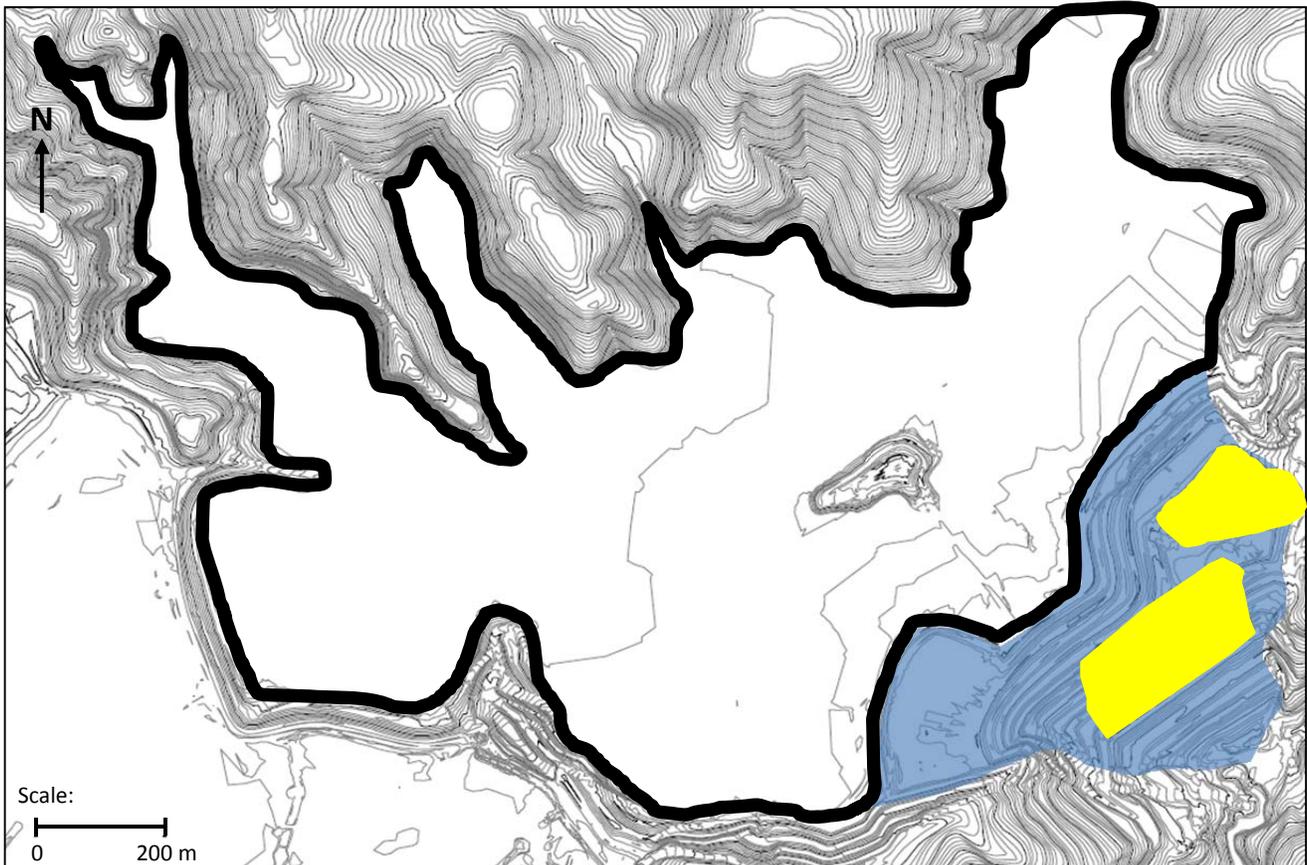
**Figure 4-11** November, 2015 configuration showing El. 826 m and El. 860 m blanket drains, raised dam, and impoundment outline

Figure 4-11 shows the drain configuration in November, 2015 with the ever-expanding impoundment. In preparation for the new 940 raise, the new blanket drain at El. 860 m had been completed at the left abutment setback and a companion drain at the right abutment was under construction. Had failure not intervened and had the dam alignment been restored, both of these new drains would have underlain the tailings much as the El. 826 m blanket drain once did. But as it was, neither had any effect on the tailings saturation that had already developed.

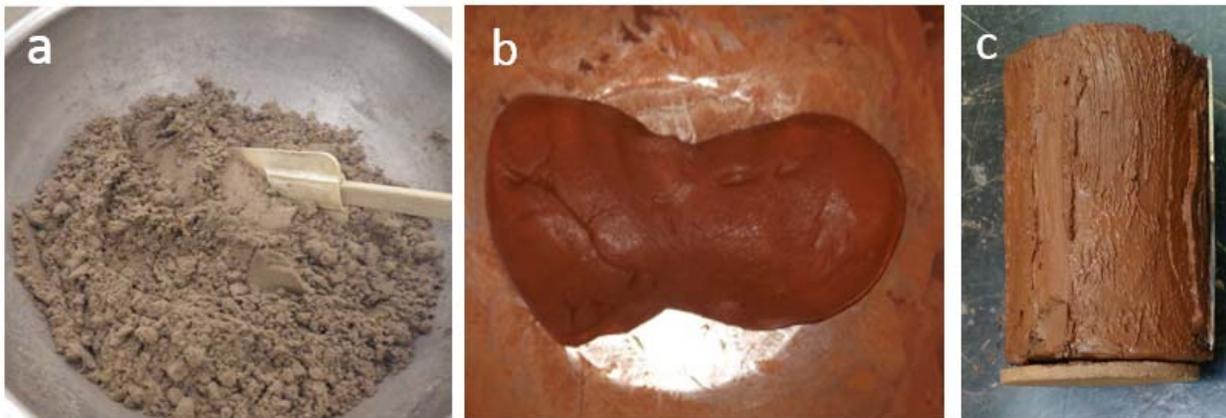
**Figure 5-1 Sand and slimes tailings. (a) sand; (b) remolded slimes; (c) intact slimes specimen**

Two types of tailings, *sands* and *slimes* were produced in the plants and conveyed in separate slurry pipelines to the Fundão and Germano impoundments. The sands are cohesionless and the slimes cohesive in character. As indicated on Figure 5-1, the two materials are readily distinguished by their color, the sands being gray and the slimes variously described as red, brown, or chocolate color.

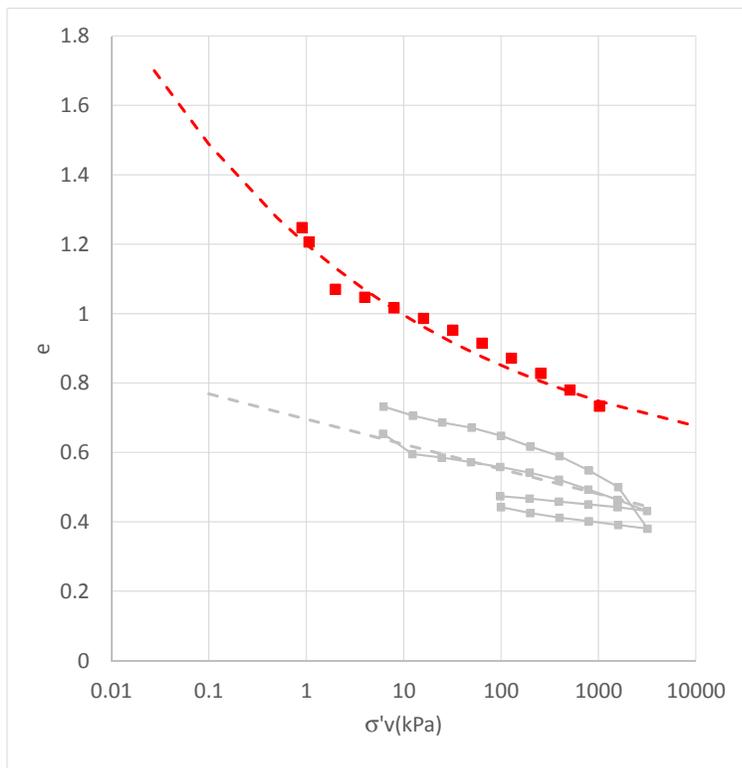
**Figure 5-3 e log p curves for sand (grey) and slimes (red) from laboratory and field data; dashed lines used in modeling**

From the standpoint of the behavior of the Fundão Dam, the most important engineering property of the slimes that distinguishes them from sands is deformability. The slimes are softer and more compressible, as indicated by the compression curves on Figure 5-3. It will be shown in the following section that deformability of the slimes was a central factor in triggering liquefaction in the sands.

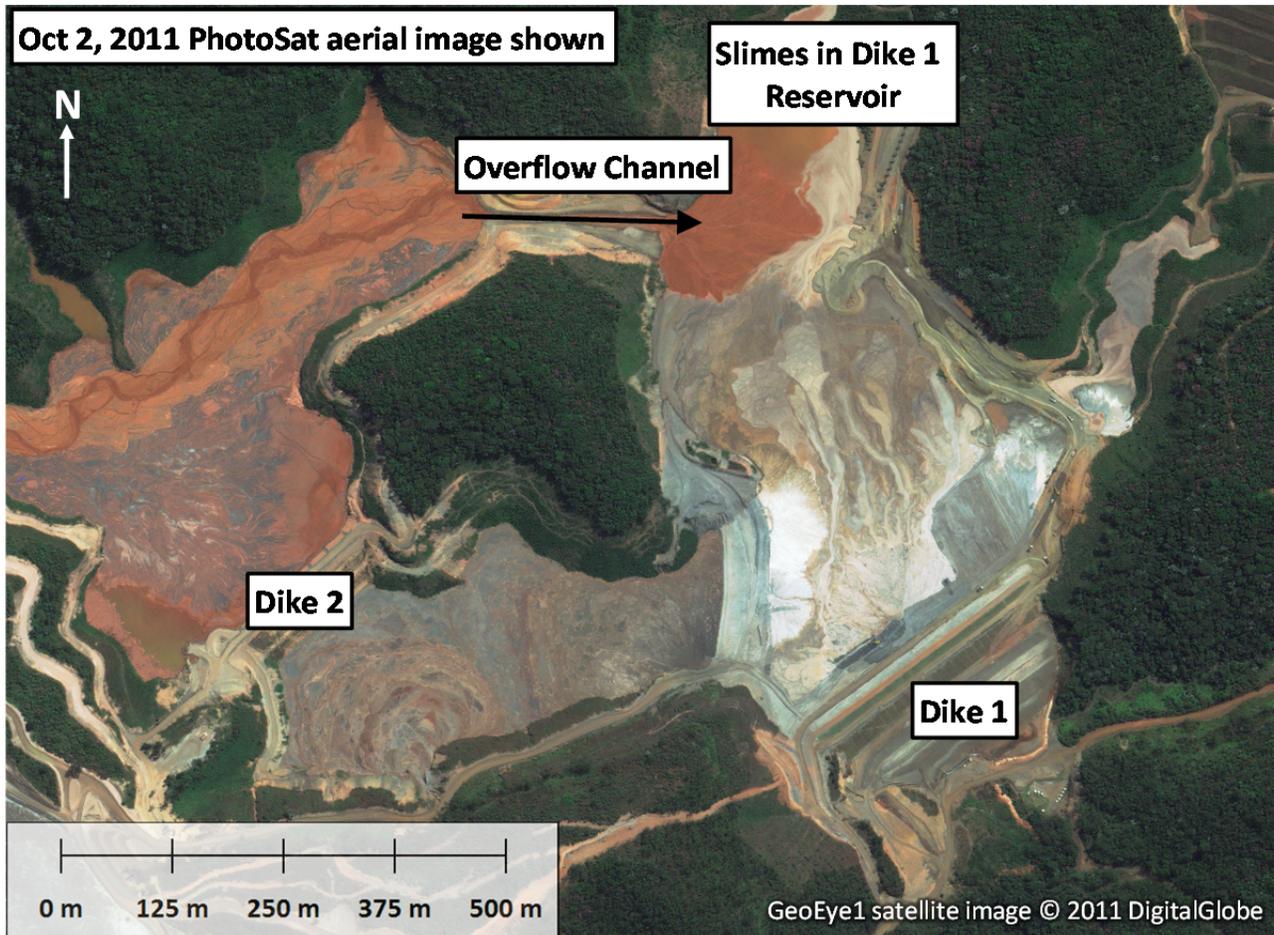
**Figure 5-5 Slimes Overflow Channel from Dike 2 reservoir to Dike 1 reservoir**

Section 2.2 described how this concept was abandoned after the Dike 1 Starter Dam was seriously damaged by piping and internal erosion. In addition, subsequent structural problems with the Main and Secondary Galleries made it necessary to re-route water and slimes from the Dike 2 impoundment into Dike 1. These problems happened during 2011 and 2012 when tailings that would later underlie the left abutment setback were being deposited. The aerial image in Figure 5-5 shows that an Overflow Channel was constructed from the Dike 2 slimes reservoir to the Dike 1 reservoir from January, 2011 to July, 2012. This Overflow Channel introduced slimes into the Dike 1 reservoir.

The Overflow Channel was closed in August, 2012 but not before slimes were deposited between El. 824 m and El. 850 m. Operation of the Overflow Channel and resulting slimes deposition is illustrated by imagery at selected dates during late 2011 and early 2012 on Figure 5-6.

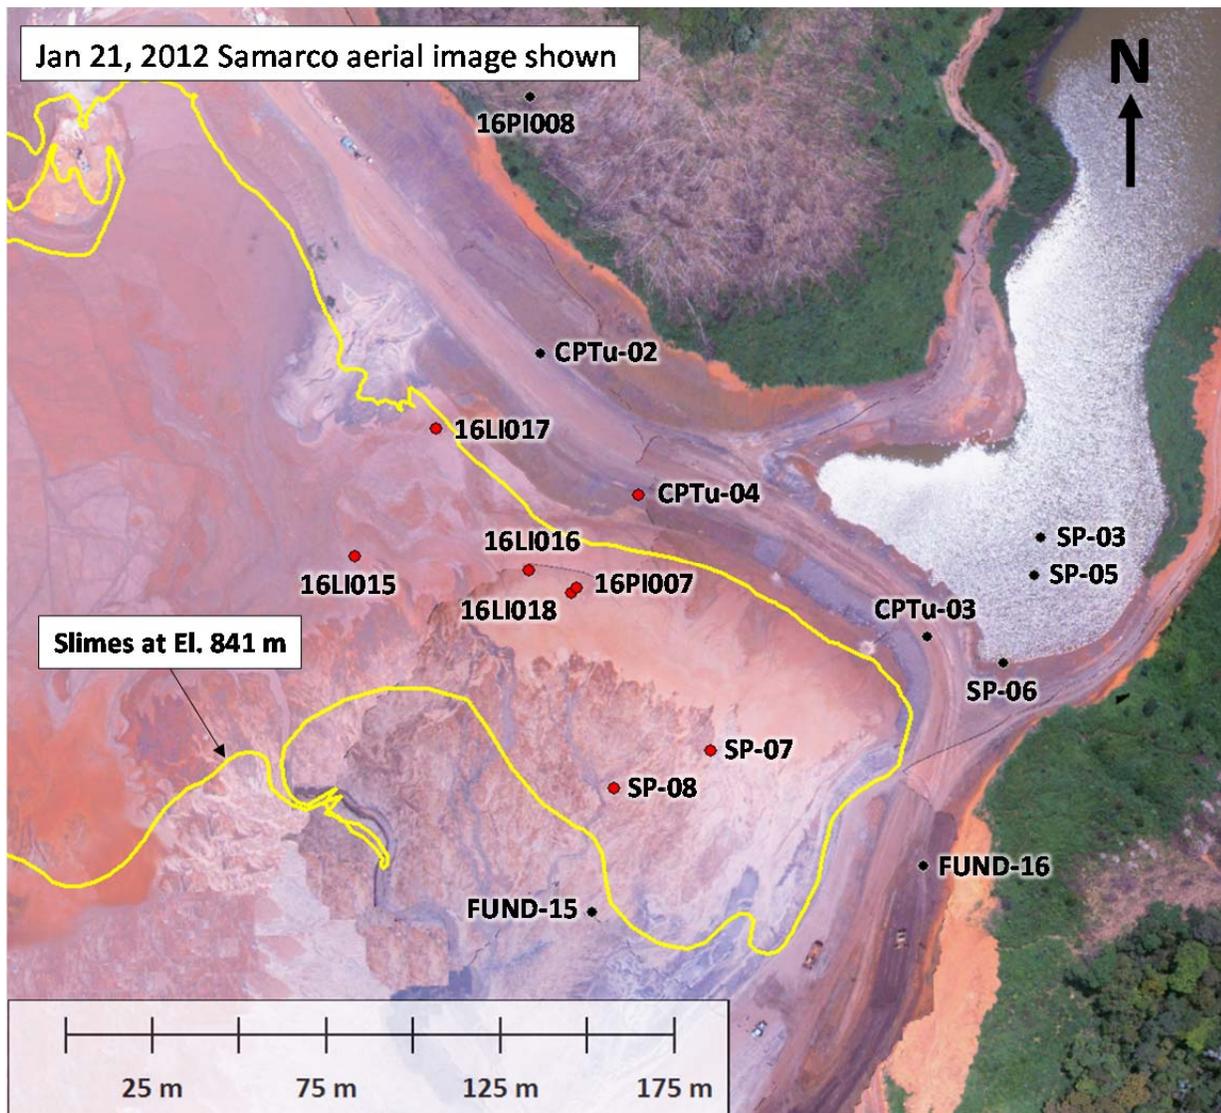
**Figure 5-7 Left Abutment Drill Holes. Red circles indicate slimes within target interval of El. 830 m to El. 850 m.**

The locations of slimes inferred from mapping can be compared to logs of drill holes through the left abutment tailings. Figure 5-7 shows borings and CPTs that penetrated a target interval of El. 830 m to El. 850 m. These holes were drilled at different times and surface elevations, but for reference they are superimposed on imagery from January, 2012. Also on Figure 5-7 for comparison are the outlines of slimes mapped at El. 841 m on that date that also appear on Figure 5-6b.

brown in color, as opposed to grey for sands, often noting the presence of clay in varying amounts. Slimes were taken in CPTs as materials having apparent fines content of 100% that are not associated with road fill or other introduced materials. On this basis, Figure 5-7 shows holes indicating the presence of slimes within the target elevation interval in red and holes with no such indications in black. It can be seen that the drill hole information corresponds to the area of mapped slimes. A number of other holes not shown on Figure 5-7 were drilled over the Secondary Gallery for purposes of investigating its foundation conditions. With a surface elevation at or near El. 835 m, they mostly penetrated tailings below the target interval.

Within those holes where slimes were identified, their distribution is more difficult to determine because the tailings were not continuously sampled. However, SP-07 is notable in having distinguished two discrete clay layers corresponding to slimes: a 2 m thick layer at El. 836.36 m and a deeper 2 m layer at El. 828.36 m. Also, CPTu-04 penetrated slimes layers up to several centimeters thick. It is reasonable then from the drill holes to categorize discrete layers of slimes as ranging from a few centimeters to a few meters in thickness, with the remainder of the slimes material intermixed with sand in varying proportions. This characterization is consistent with the zone of interlayering and intermixing portrayed on Figure 5-4.

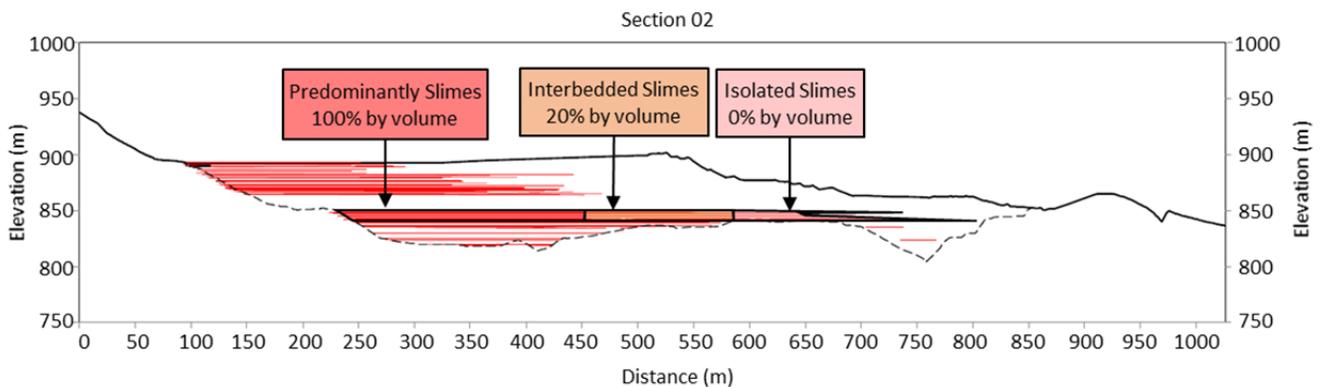
**Figure 5-8** Distribution of slimes at left abutment

The mass balance provides a measure of the volumetric proportion of constituent slimes and slimes layers within a specified zone. Figure 5-8 portrays the results in cross section. Here, the region designated *predominantly slimes* is nearly 100% slimes, *interbedded slimes* is estimated to contain 20% or more slimes overall, and the zone of *isolated slimes* less than this amount. Although distinct boundaries are shown between these regions, actual conditions are transitional in character.

The preceding discussions have shown that slimes were present at the left abutment, in particular between El. 830 m and El. 850 m, and that their concentration increased with distance behind the dam. How these conditions influenced the embankment requires accounting for the setback.

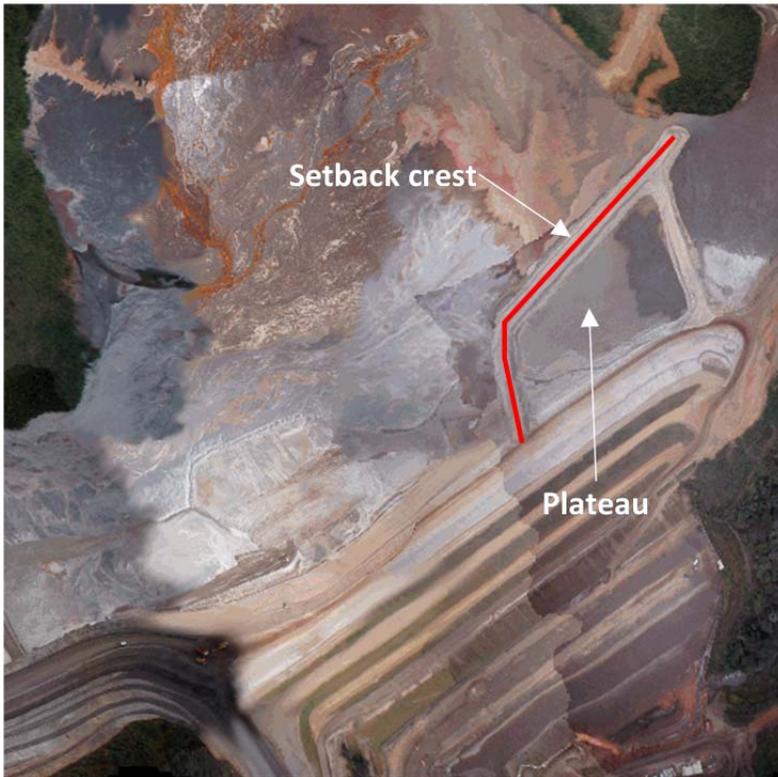
**Figure 5-9** Aerial photograph of the setback alignment in October, 2012

Circumstances surrounding the modification of the dam alignment that resulted in the setback have been reviewed in Section 2.4. Due to structural problems and construction defects, the dam could not continue to be raised over the Secondary Gallery until repairs had been made. But when these repairs proved unsuccessful, the Secondary Gallery had to be abandoned and filled with concrete. To accommodate tailings storage requirements during these periods, beginning in October, 2012 the dam alignment at the left abutment was shifted back from its former location as shown on Figure 5-9. This created what is called here the *setback*, with the vacant area in front of it the *plateau* or *platform*.

The setback was initiated when the plateau was at approximately El. 855 m. By the end of 2013, the crest had risen to El. 877 m, or about 22 m high.

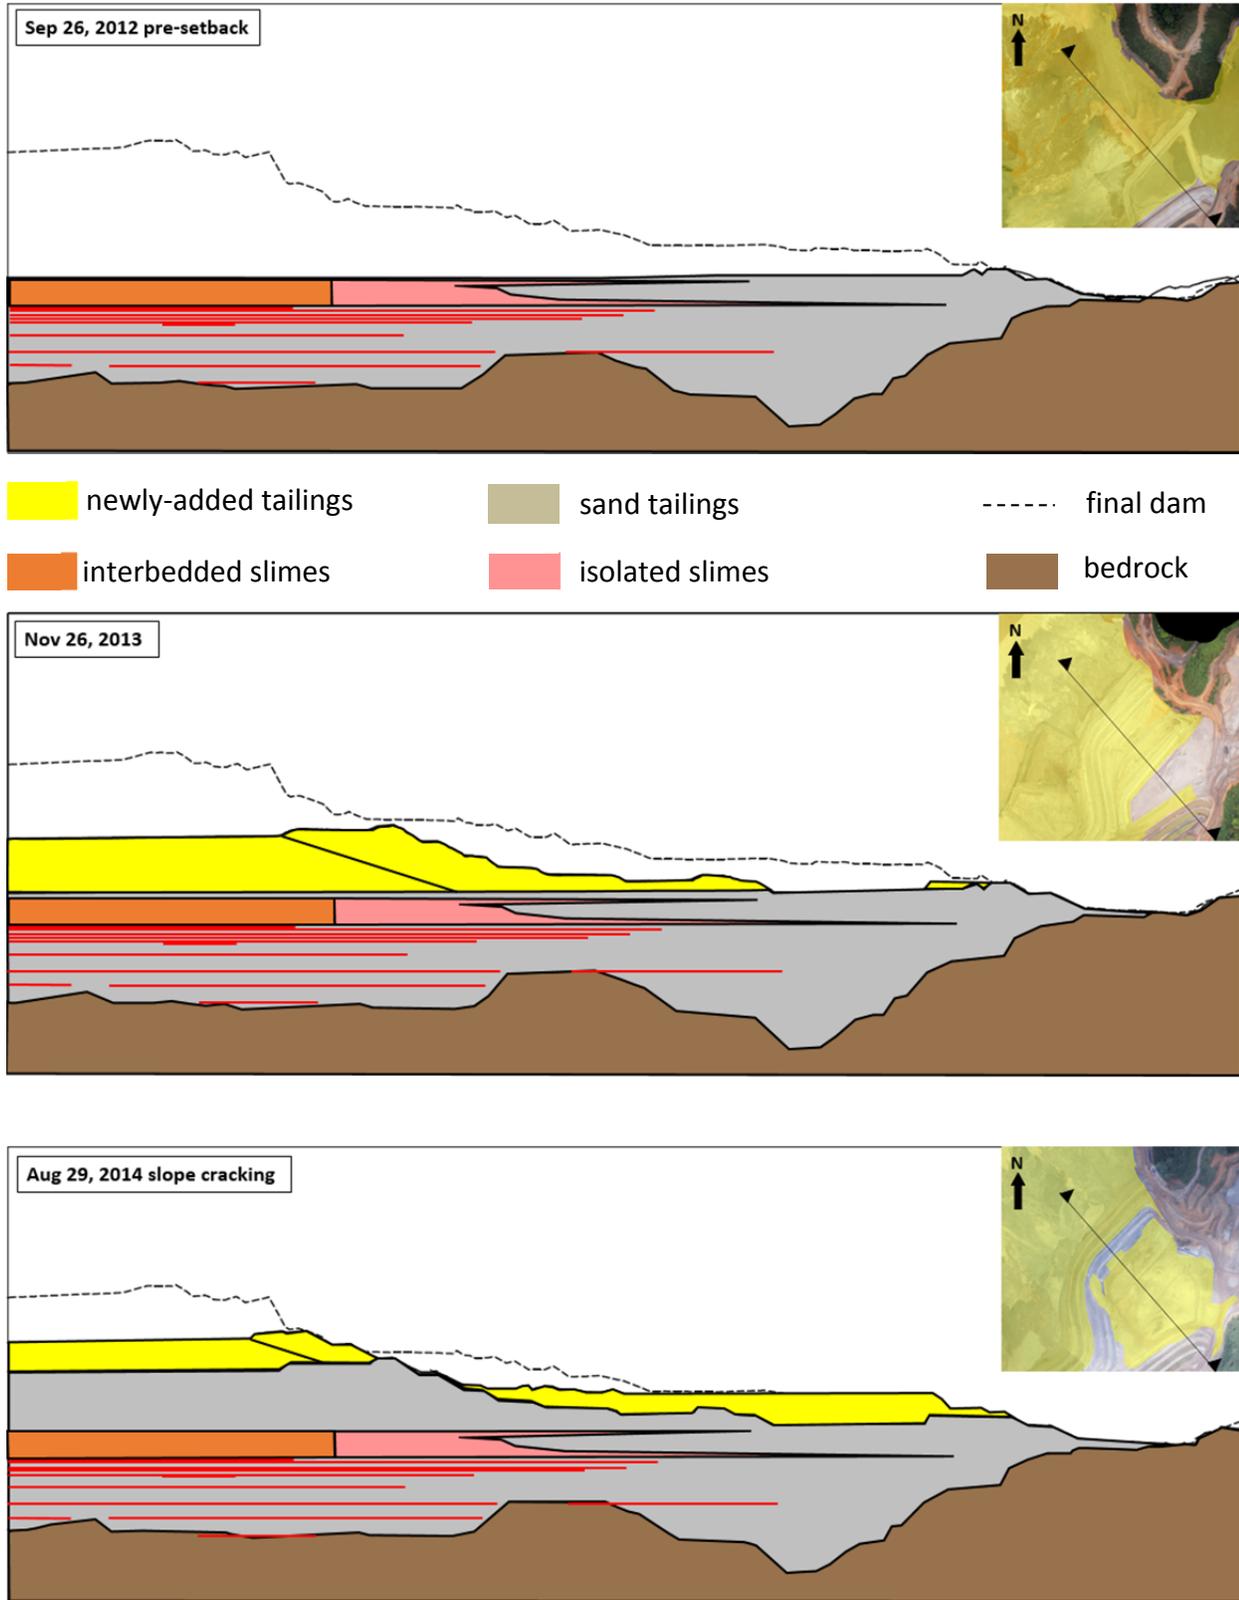
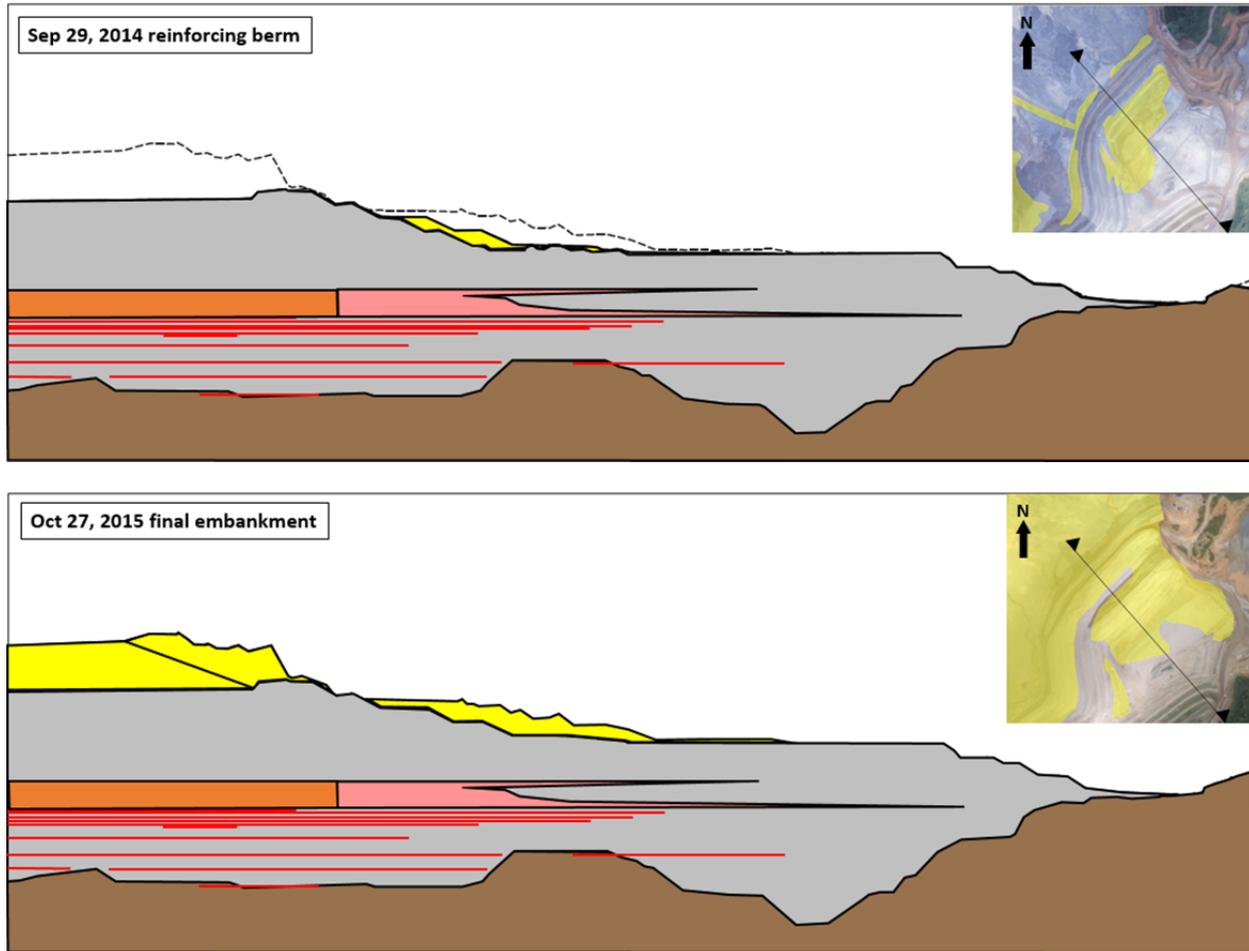
**Figure 5-10 Sequential raising of setback embankment over slimes**

The combined effect of the slimes deposition described in Section 5.1 and the setback is best shown by a series of illustrations representing various points in time. The extent of newly-added tailings since the previous time step is indicated on the sections and in plan view on the insets to Figure 5-10. Compacted tailings that were mechanically placed during embankment raise construction are distinguished from the hydraulically-discharged sands by lines separating the two on the cross sections.

Figure 5-10 shows that the alignment setback caused all or most of the embankment to be constructed over slimes. In addition, as the embankment became higher and its crest moved upstream, more of the embankment slope became underlain by the higher proportion of slimes in the interbedded region.
