# Fundão Tailings Dam Review Panel

## Report on the Immediate Causes of the Failure of the Fundão Dam

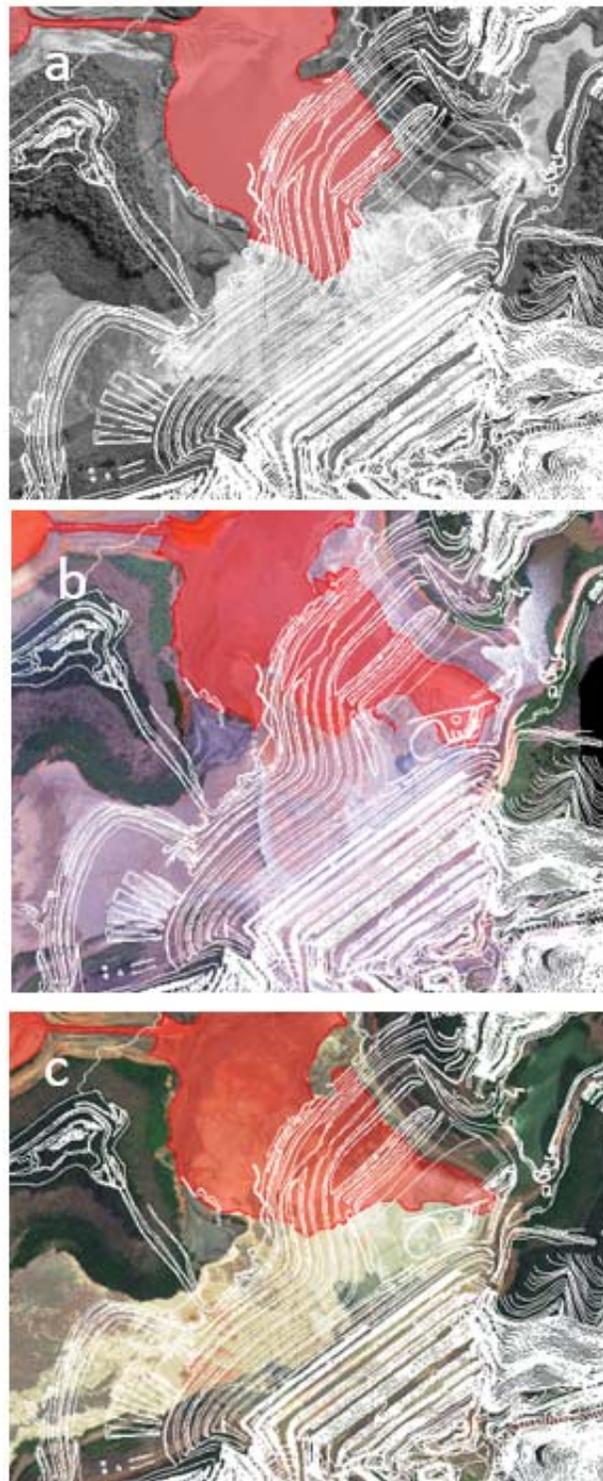
**Figure 5-11** Slimes beneath final embankment: (a) September 20, 2011; (b) January 21, 2012; (c) March 3, 2012. Slimes highlighted in red; final embankment contours in white

The areal extent of the slimes depicted on Figure 5-10 deposited in 2011 and 2012 beneath the left abutment setback is shown on Figure 5-11, where again it can be seen that by the time the embankment reached its final height, slimes would be present beneath the entire setback slope and much of the plateau area.

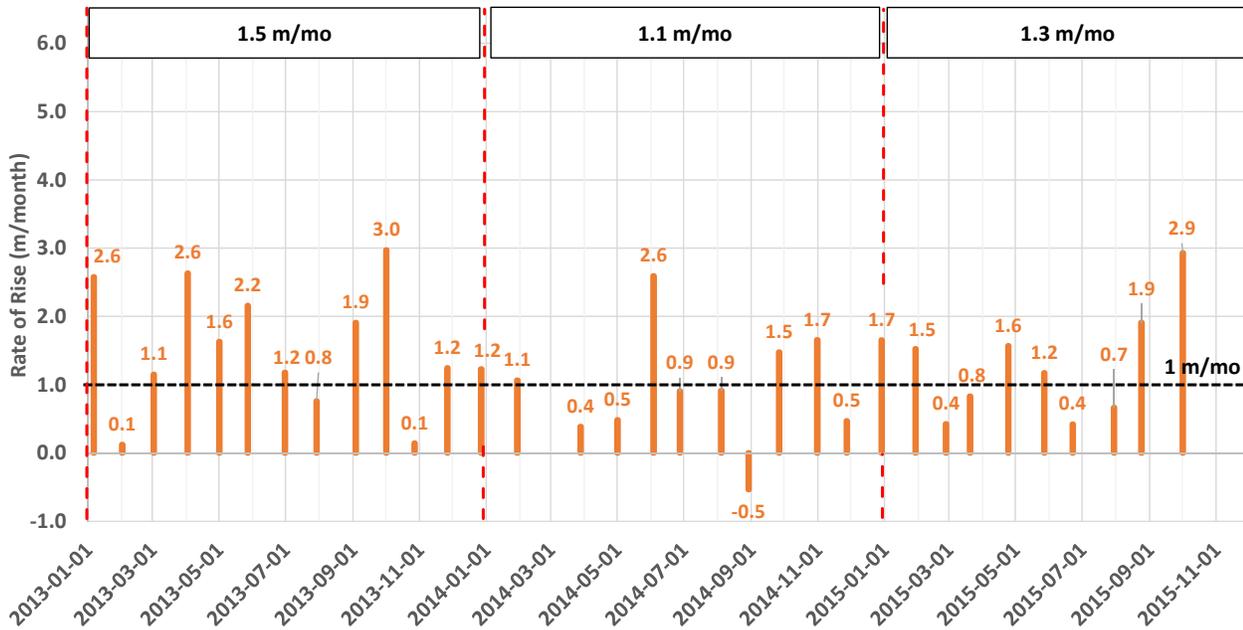
Figure 5-12 Rate of dam crest rise at left abutment setback

As indicated on Figure 5-12, the rate of rise of the dam crest at the left abutment varied during the life of the setback. The average 1.3 m/mo during 2015, or an annualized rate of 15.7 m/yr, was intermediate between rates experienced during 2013 and 2014. Also during 2015 in the months immediately prior to failure, raising accelerated from as low as 0.4 m to 2.9 m. The small negative rate of rise in September, 2014 was produced by regrading related to construction of the reinforcing berm and is not consequential to the overall trend.

In addition to the stresses applied, the loading due to embankment raising must also be considered. This was based on actual survey data, as illustrated in Appendix B. As previously shown on Figure 5-12, the rate of rise at the left abutment reached a value of 2.9 m/month. There is no evidence that this rate had a material effect on the sands, but it could certainly induce an increment of undrained loading on the underlying slimes.

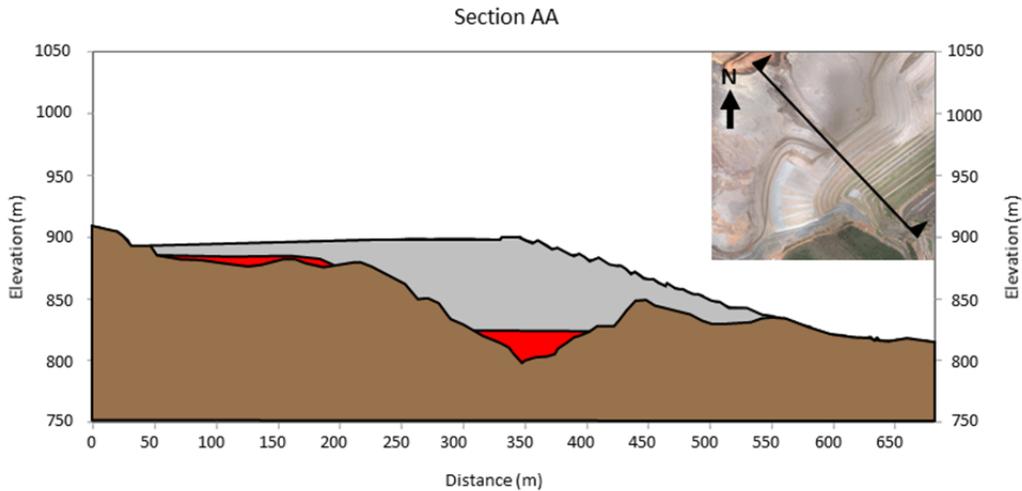
**Figure 5-13 Slimes at right abutment Section AA**

Figure 5-13 shows Section AA at the right abutment and its internal composition based on mapping as described in Section 5.1.3. The distinguishing feature of the right abutment compared to the left is the nearly complete absence of slimes beneath the embankment slope. The only region of slimes lies below El. 825 m where it is confined both upstream and downstream by natural ground. This is in sharp contrast to the left abutment on Figure 5-8 where slimes can be seen to extend beneath virtually the entire length of the slope.

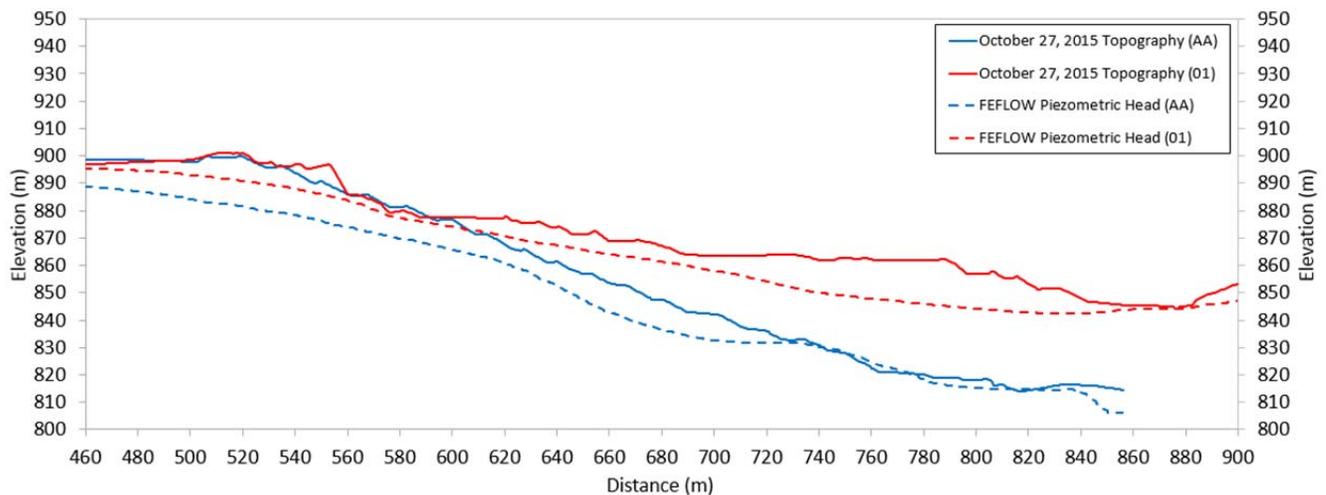
**Figure 5-14 Geometry and piezometric comparison of left and right abutments**

The left and right abutments can be compared more directly by overlaying the respective sections. Figure 5-14 provides an overlay of Section 01 at the left abutment and right abutment Section AA, coincident at the respective dam crests. Geometrically, the greater overall steepness and extended length of the 3.0H:1.0V right abutment slope stands out.

Also depicted on Figure 5-14 is the difference between the piezometric surface at the two locations, with generally higher conditions on the left that reflect the influence of slimes. This is illustrated in more detail on Figure 5-15.

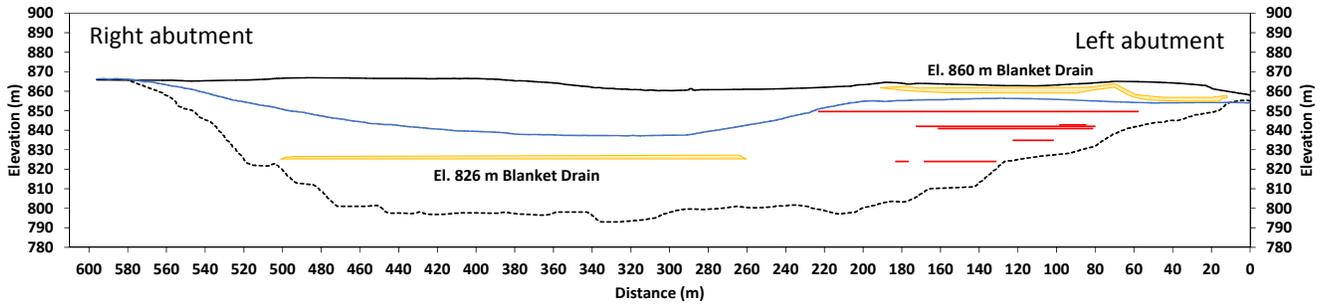
**Figure 5-15 Longitudinal section from FEFLOW, view looking upstream. Phreatic surface shown in blue, El. 826 m blanket drain in yellow, slimes in red.**

Figure 5-15 is based on results of a 3D steady state and transient seepage analysis of the tailings impoundment performed as part of the Investigation and described in Appendix G. The estimated phreatic surface from this modeling is shown on the longitudinal section. On the left abutment, inflows from Grota da Vale together with the slimes maintain the phreatic surface at a higher elevation. In contrast to the right abutment, the slimes on the left extend outward toward the El. 826 m blanket drain and limit the lateral extent of its influence.

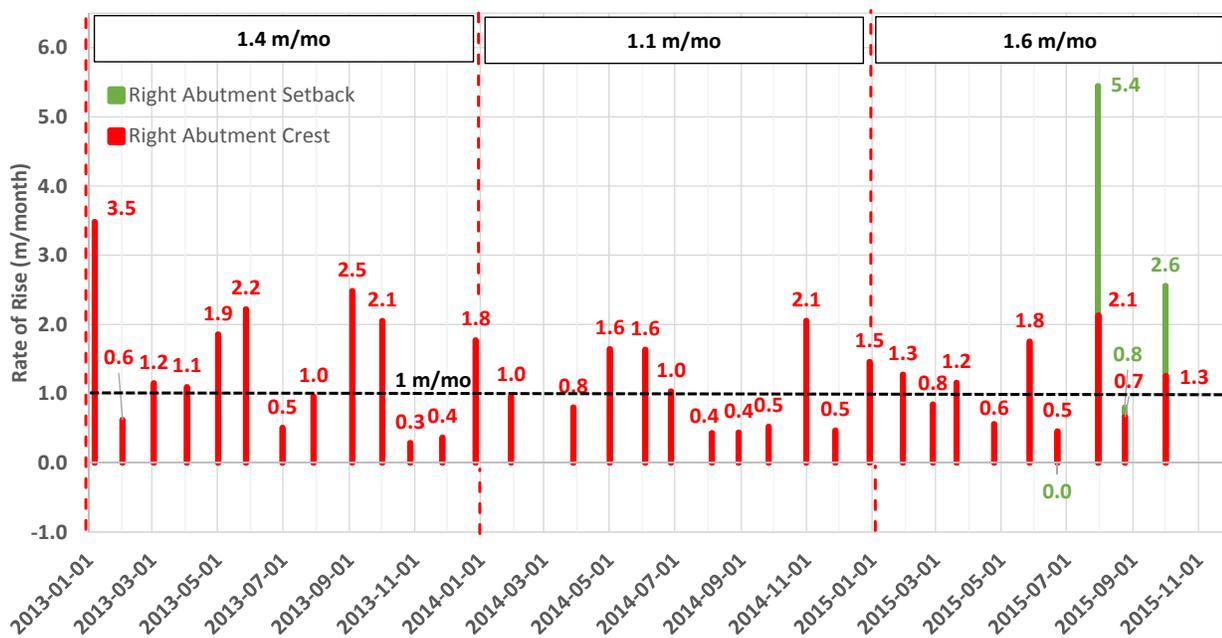
**Figure 5-16 Rate of rise at right abutment**

The rate of rise of the embankment crest at the right abutment is shown on Figure 5-16, which can be compared to conditions at the left from Figure 5-12. Average annual rates are generally similar except during 2015 when the right abutment was raised at a higher rate of 1.6 m/mo compared to 1.3 m/mo on the left. The right abutment experienced an unusually high rate of rise of 5.4 m/mo in August, 2015 on a newly-initiated realignment of the crest that was set back from the former location to allow for drain construction depicted on Figure 2-12.

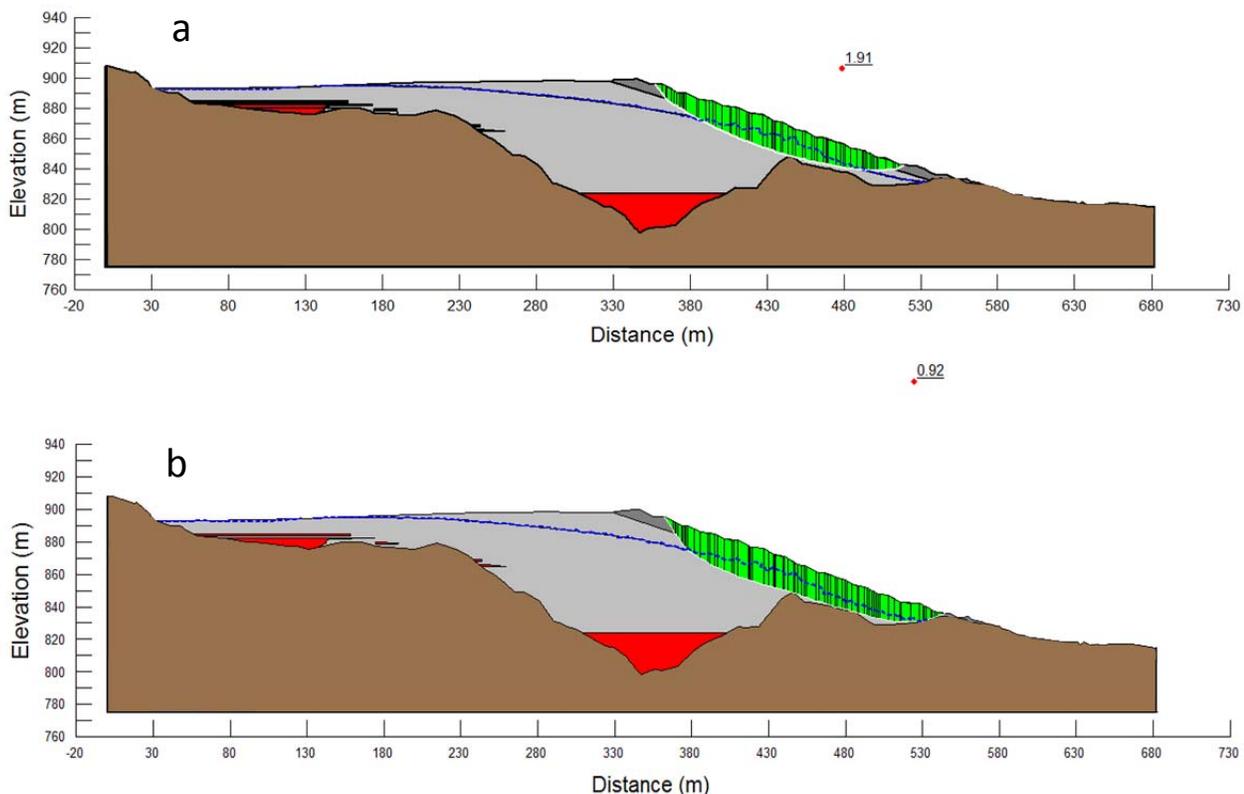
**Figure 5-17** Stability analyses at right abutment Section AA; (a) effective stress (ESA); (b) undrained strength (USA)

Stability analyses for the right abutment Section AA on November 5, 2015 are shown on Figure 5-17 for both ESA and USA, where a calculated factor of safety (FS) less than 1.0 indicates failure. The ESA adopts a friction angle of 35 degrees and 5 kPa for compacted tailings fill and 33 degrees and zero kPa for hydraulically-discharged tailings, while the USA uses an undrained strength ratio in compression of 0.25 for tailings below the piezometric surface.

Figure 5-17 shows  $FS = 1.91$  for ESA conditions and  $FS = 0.92$  for USA. Hence, with a USA factor of safety less than 1.0, rapid failure and associated flowsliding should have initiated at the right abutment if undrained conditions had been operative. The fact that failure did not initiate there means that undrained strength was not fully mobilized and that drained conditions represented by the ESA prevailed at the right abutment. It is equally apparent that the rate of embankment rise at the right abutment was not itself sufficient to mobilize undrained strength in the sand tailings.

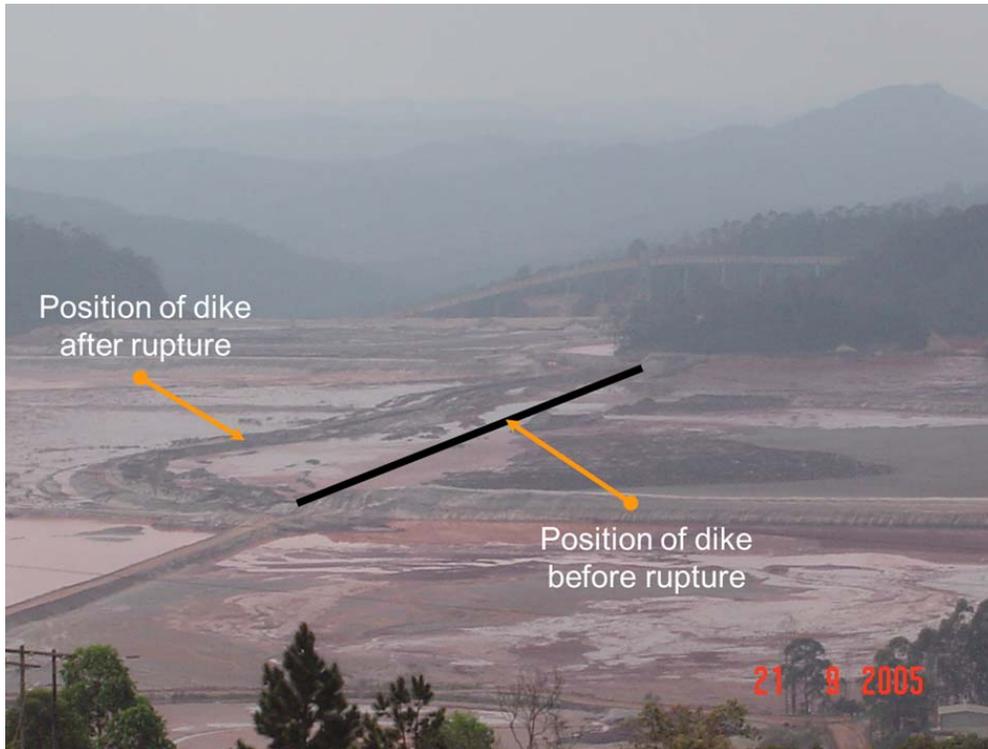
**Figure 6-1** 2005 Baia 4 static liquefaction failure

An important case of static liquefaction occurred at the Germano Complex itself in 2005. As shown in Figure 6-1, a low dike being raised over interlayered and intermixed slimes in the Baia 4 area experienced a sudden, high-mobility failure that moved rapidly over a distance of 80 m. The Baia 4 failure was attributed to liquefaction.

The Baia 4 failure provided the basis for determining parameters for slimes-rich layers used in modeling of the Fundão failure. Specifically, parameters relating to the peak undrained shear strength of these layers and the reduction in strength at large deformations were derived by back calculation from pre-failure and post-failure conditions. In these respects, the Baia 4 failure provided an important link between the theoretical studies conducted by the Panel and actual experience at the Germano Complex itself (see Appendix C for details).

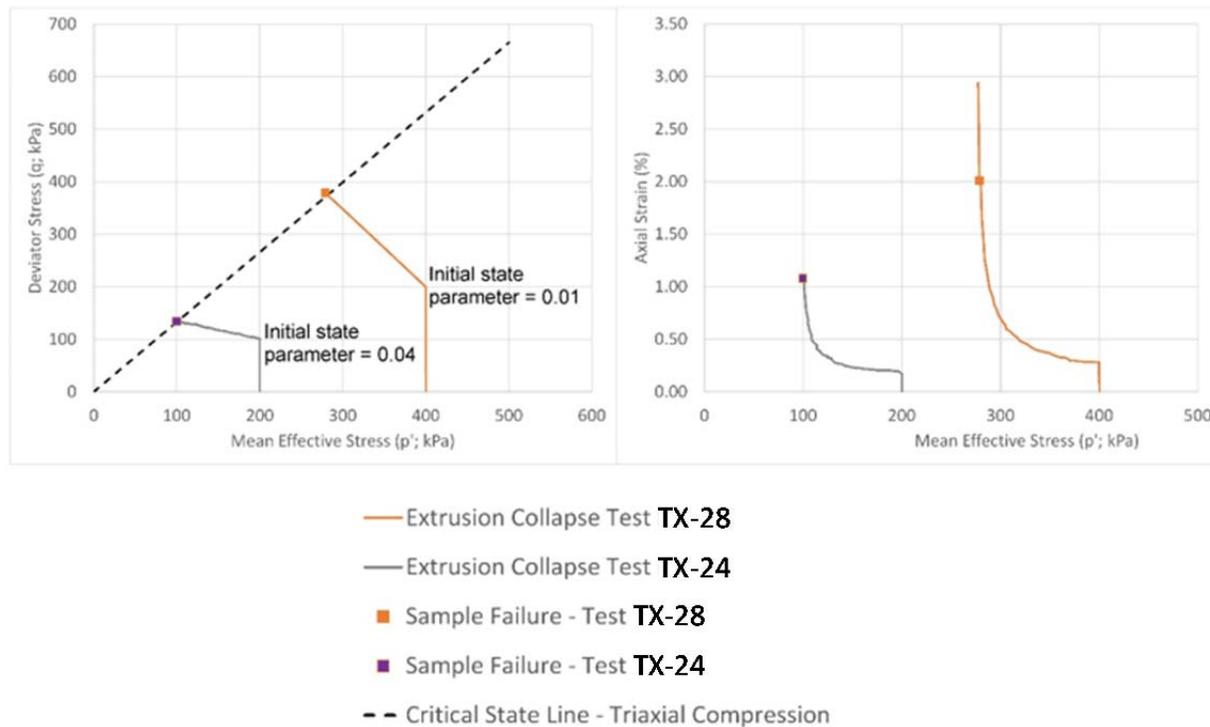
**Figure 6-3 Extrusion collapse tests on Fundão sand**

The Panel has experimentally demonstrated the lateral extrusion mechanism leading to collapse by conducting drained triaxial compression tests that adopt a specially-designed stress path. Designated *extrusion collapse* tests, they simulate the reduction in horizontal stress in the sand due to slimes extrusion while keeping the vertical stresses constant. Details of the test procedures and data obtained are provided in Appendix D, which includes the results from the tests that were performed. The results of two tests are shown on Figure 6-3, one on a contractive specimen with an initial state parameter  $\Psi = +0.01$  and another with  $\Psi = +0.04$ . These values are on the contractive side of CPT data previously shown on Figure 4-4 and as such tend to bracket the characteristic state in the field. In both cases, as the shear stress along this loading path approaches the ultimate friction line, collapse occurs in an abrupt and sudden manner after only small deformations in the sand. This testing provides both a qualitative demonstration and a quantitative reference for collapse of Fundão sand associated with the extrusion mechanism.

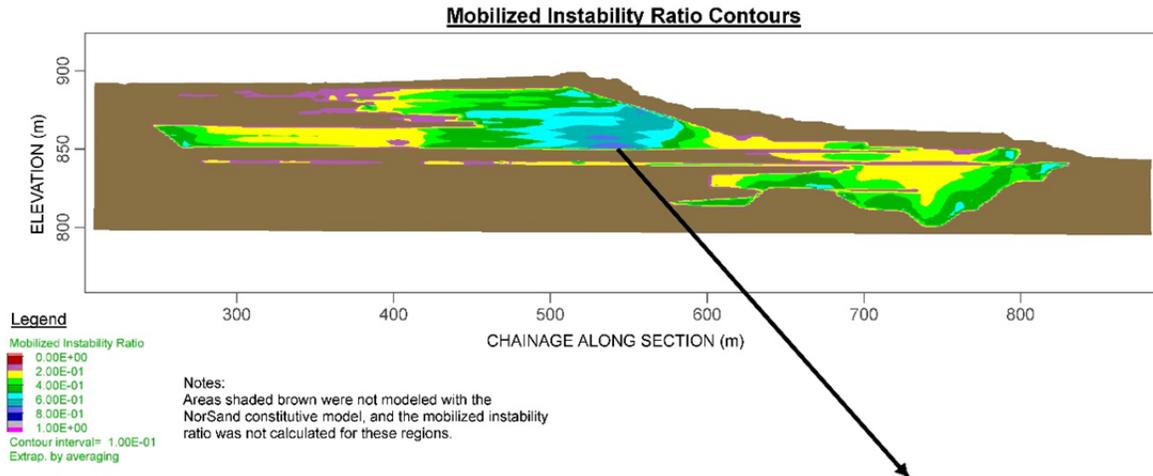
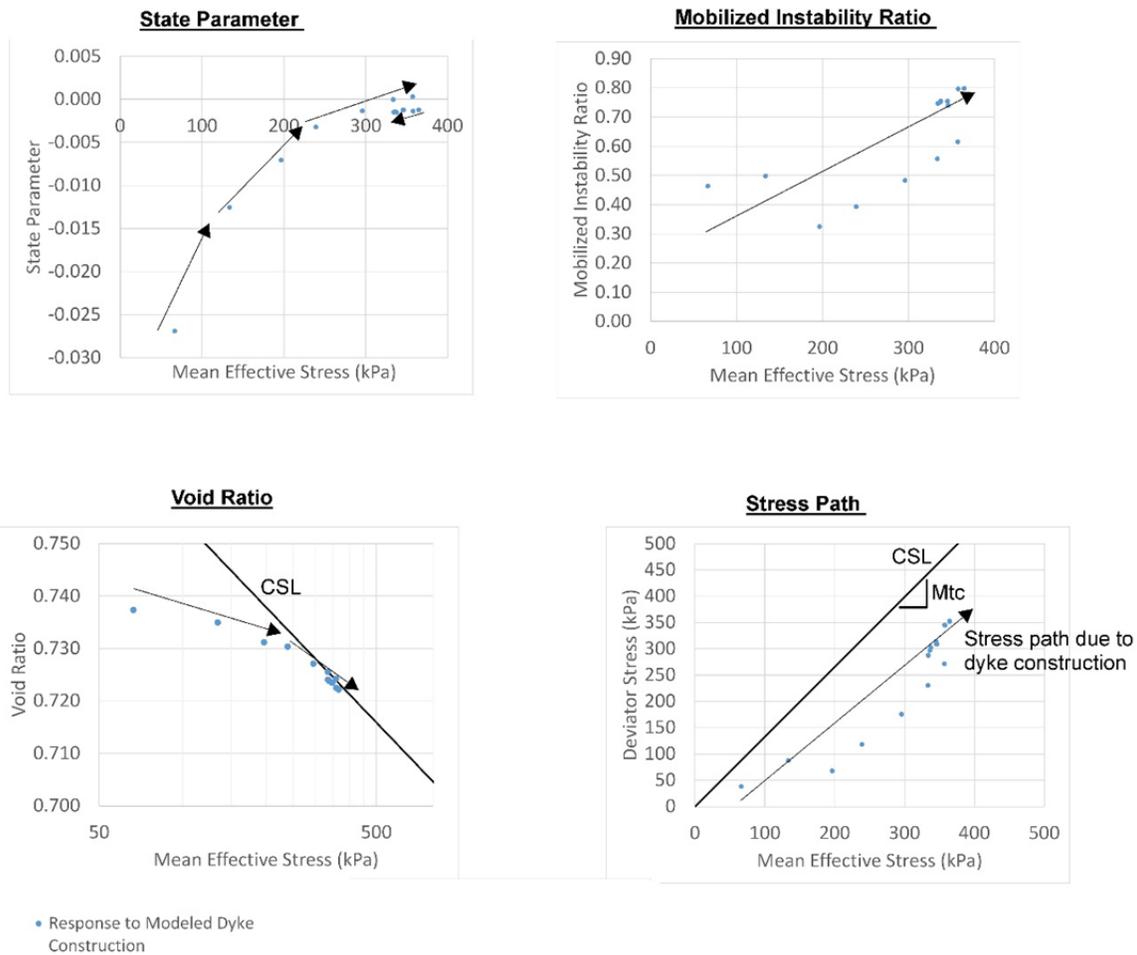
**Figure 6-6 Mobilized Instability Ratio**

The Mobilized Instability Ratio (MIR) is a criterion for the triggering of collapse. It is defined as the ratio of the deviator stress and mean effective stress to the ratio at the onset of collapse. The color zonation represents the MIR related to the collapse strength determined from laboratory tests. The maximum value computed is 80%. Numerical convergence limitations inhibit the modeling from progressing further. However, the information available from the simulation provides compelling support for the hypothesis that collapse was triggered by lateral extrusion of the slimes-rich deposits.

Figure 6-6 also plots the stress path calculated throughout construction of the Fundão Dam. Operation of the lateral extrusion mechanism is cumulative during construction as reflected by the results plotted. The stress path has been calculated at the base of the sand which is the location where collapse would be initiated. The calculation indicates that 80% of the available collapse resistance has been mobilized with the strength as prescribed in the analysis and determined by laboratory tests. Numerical instability, from a computational perspective, precluded advancing the calculations further.

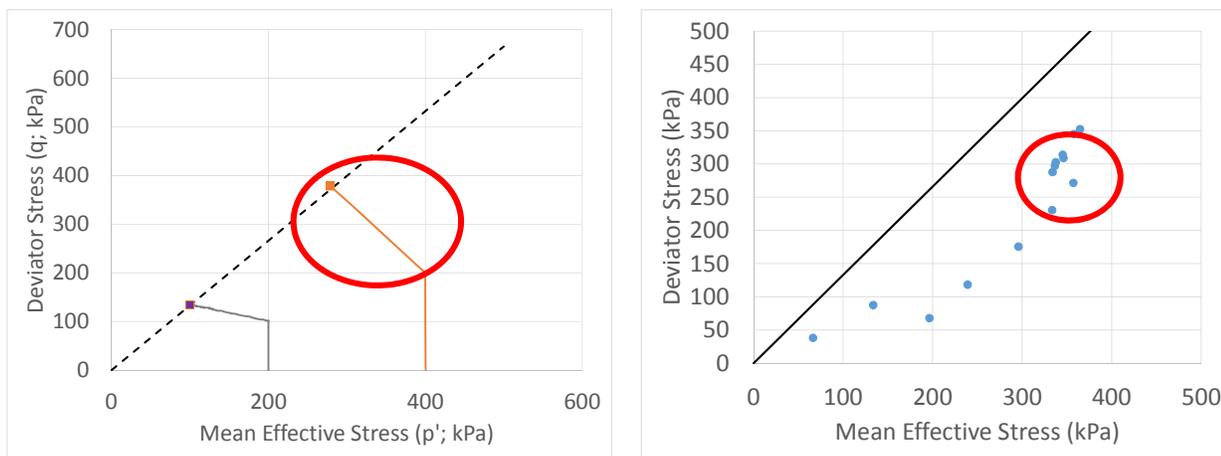
**Figure 6-7 Comparison of laboratory and simulated field stress path**

Figure 6-7 provides a comparison of laboratory data from Figure 6-5 with the simulated field stress path on Figure 6-6. It shows that the field stress path displays similarity to the controlled laboratory stress path and is migrating towards the ultimate strength line. As noted above, numerical convergence limitations preclude completing the analysis.

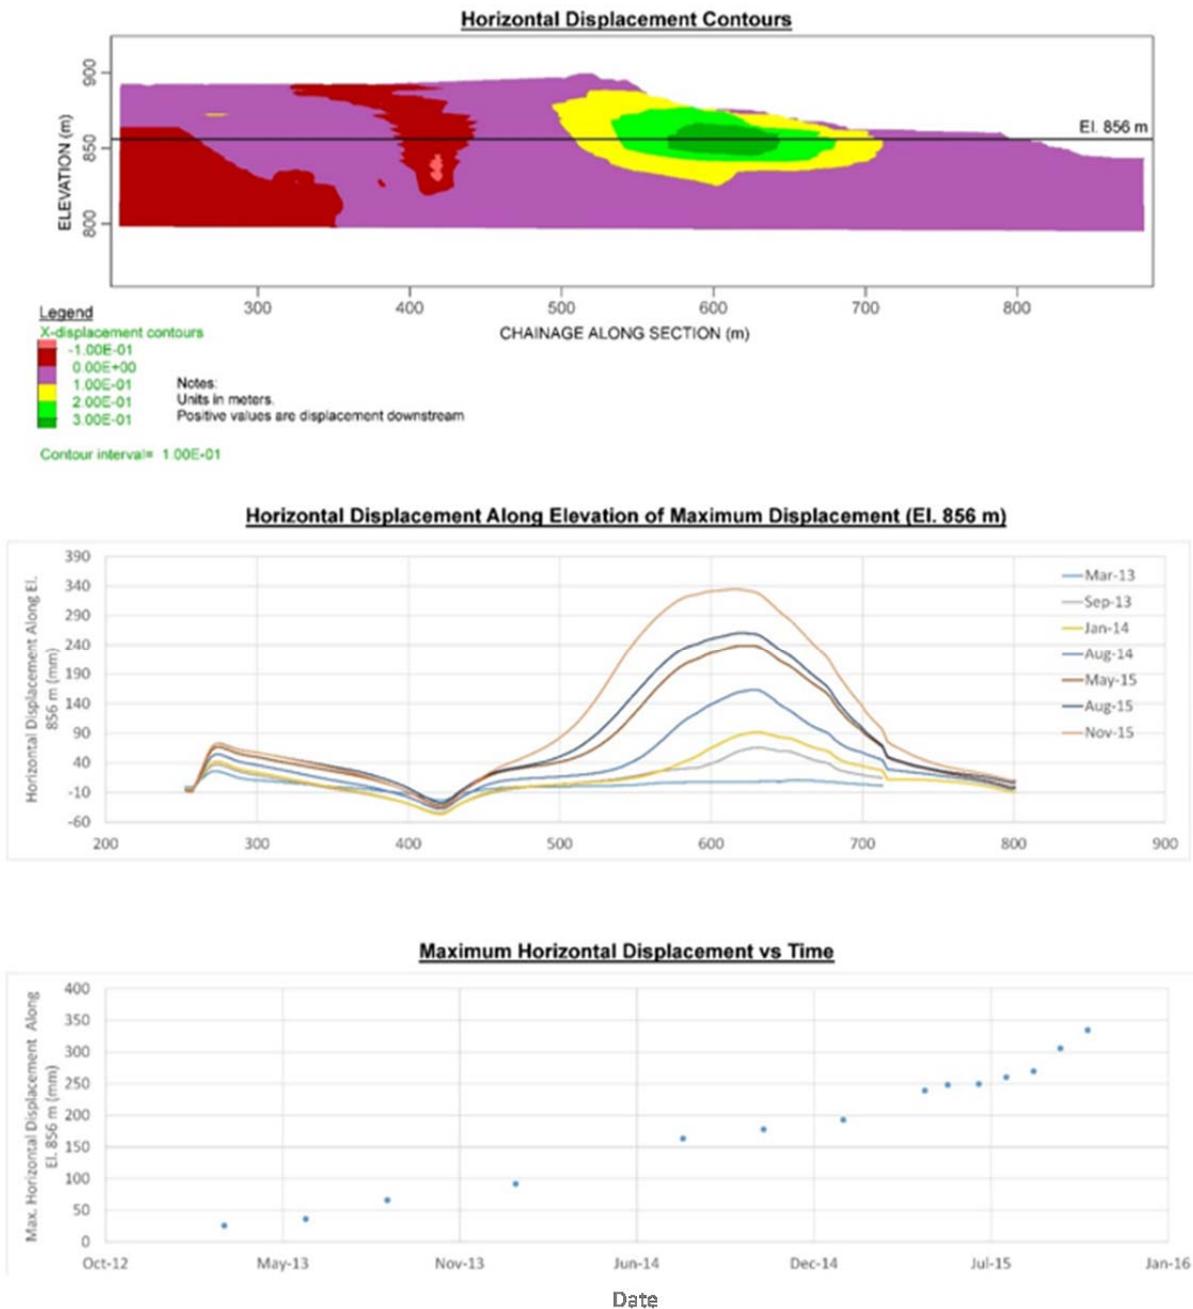
**Figure 6-8 Horizontal displacements at sand/slimes interface**

Figure 6-8 plots horizontal deformations along the slimes/sand interface at various stages of construction of the Fundão Dam. It illustrates that the largest lateral movements occur beneath the slope and downstream of the crest. This implies compressive straining in the downstream direction and extension straining in the upstream direction. Extension strains result in a reduction of horizontal confinement consistent with the lateral extrusion hypothesis.

It is also of interest to note that the maximum horizontal displacements beneath the lower part of the slope coincide with eyewitness reports of slope movement having initiated on the lower benches, as described in Section 2.7.

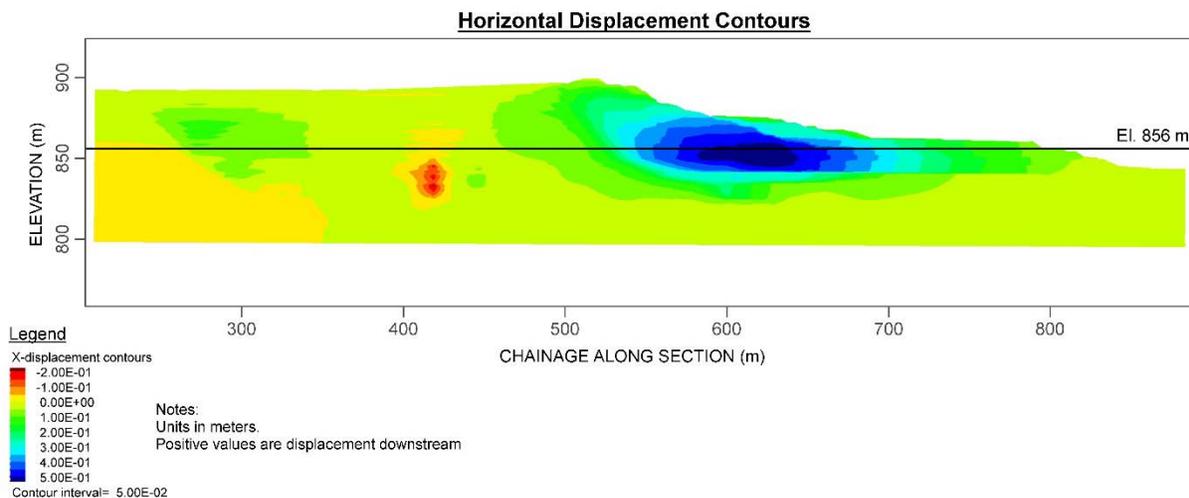
**Figure 6-9 Horizontal displacements resulting from Mohr-Coulomb analysis approaching a factor of safety of unity**

The pattern of displacements resulting in November, 2015 if a factor of safety of unity was approached is shown on Figure 6-9. The pattern of displacements is similar to that shown previously for the NorSand model analyses.

The deformation model used for failure analysis is equivalent to limit equilibrium analysis and hence provides a linkage between sliding displacement at failure and factor of safety. As discussed earlier in this section, a factor of safety of unity represents a trigger for the onset of liquefaction. The deformations associated with the onset of liquefaction with the shearing mechanism are much greater than those associated with the lateral extrusion mechanism. Therefore, liquefaction would be initiated by lateral extrusion prior to the development of shear failure.

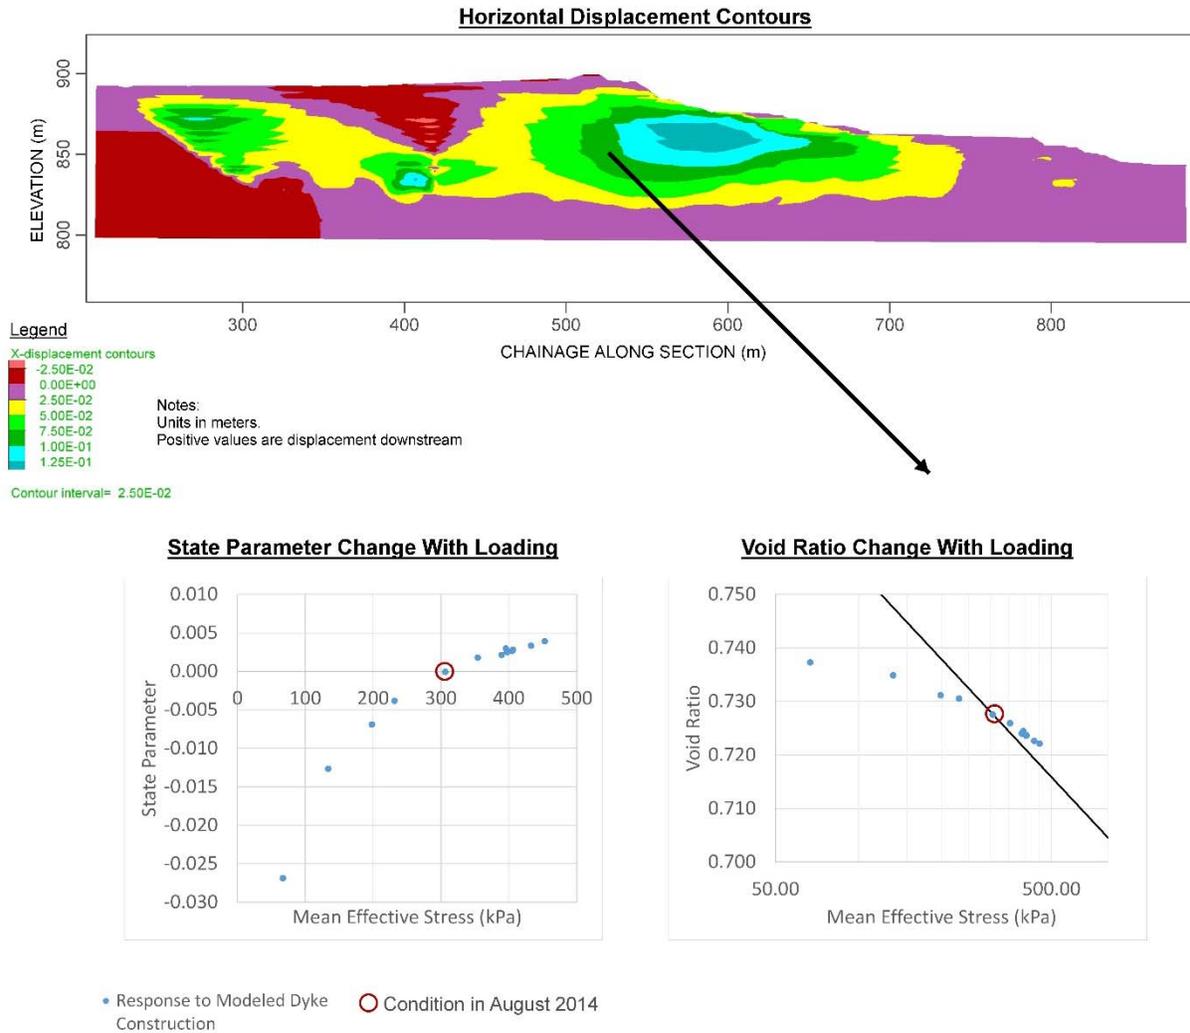
**Figure 6-10 Example NorSand model output**

The August, 2014 cracking incident did not display the mobility associated with flowsliding indicating that liquefaction did not occur. Figure 4-3 previously explained in principle how increased loading can cause a formerly dilatant material to become contractant. This effect is displayed in the NorSand model of conditions prevailing on or about August of 2014. As shown on Figure 6-10 on August, 2014 the sand is on or close to the CSL, which is a boundary between contractant and dilatant behavior. At this point the sand became loose enough to exhibit volume change and associated cracking but was not sufficiently loose to exhibit liquefaction. Also, Section 4.3 explained that a fundamental change in seepage patterns happened on or about the same time. Together these two changes, one in sand behavior and the other in saturation, produced the observed effects.
